Access Compliance Report

Public Rights-of-Way

(Island Curb Cuts)

Intersection ID: 13713	Main Street: UNIVERSITY POINTE BV	Cross Street: IBM DR	Location: S
ADA ID: C4AA7EB228E1	Curb Cut Type: MedianRefuge2	Initial Pass/Fail: Fail	Overall Compliance: No
Severity Score: 1.25			
Codes/Mitigation Info/Possible Solution		Field Measurements/Component Compliance

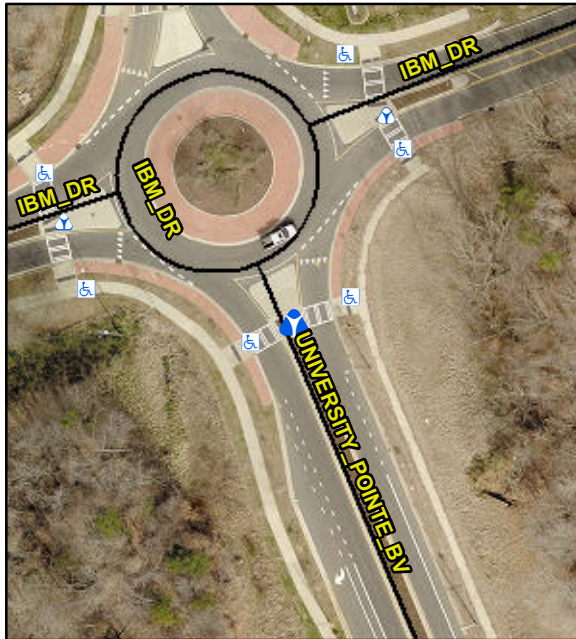
Compliance	Description	Data	Compliance	Description	Data
Yes	Refuge 1 Length (In)	62.0	N/A	Gutter 1 Ponding?	N/A
Yes	Refuge 1 Width (In)	124.5	N/A	Gutter 1 Lip Ht (In)	N/A
Yes	Refuge 1 Slope (%)	3.1	N/A	Gutter 1 Slope (%)	N/A
Yes	Refuge 1 X Slope (%)	4.9	N/A	Gutter 1 X Slope (%)	N/A
N/A	Painted X Walk1?	No	N/A	DWS 1 Provided?	N/A
N/A	X Walk 1 Direction	To E	N/A	DWS 1 Contrast?	N/A
N/A	X Walk 1 Width (In)	N/A	N/A	DWS 1 Length (In)	N/A
N/A	Road 1 Slope (%)	4.7	N/A	DWS 1 Full Width?	N/A
N/A	Road 1 X Slope (%)	2.1	N/A	DWS 1 Offset (In)	N/A
Yes	Refuge 2 Length (In)	62.0	N/A	Gutter 2 Ponding?	N/A
Yes	Refuge 2 Width (In)	124.5	N/A	Gutter 2 Lip Ht (In)	N/A
Yes	Refuge 2 Slope (%)	1.0	N/A	Gutter 2 Slope (%)	N/A
Yes	Refuge 2 X Slope (%)	4.8	N/A	Gutter 2 X Slope (%)	N/A
N/A	Painted X Walk2?	No	N/A	DWS 2 Provided?	N/A
N/A	X Walk 2 Direction	To W	N/A	DWS 2 Contrast?	N/A
N/A	X Walk 2 Width (In)	N/A	N/A	DWS 2 Length (In)	N/A

N/A	Road 2 Slope (%)	5.0	N/A	DWS 2 Full Width?	N/A
N/A	Road 2 X Slope (%)	4.7	N/A	DWS 2 Offset (In)	N/A
N/A	Refuge 3 Length (in)	N/A	N/A	Gutter 3 Ponding?	N/A
N/A	Refuge 3 Width (in)	N/A	N/A	Gutter 3 Lip Ht (in)	N/A
N/A	Refuge 3 Slope (%)	N/A	N/A	Gutter 3 Slope (%)	N/A
N/A	Refuge 3 XSlope (%)	N/A	N/A	Gutter 3 XSlope (%)	N/A
N/A	Painted X Walk3?	No	N/A	DWS 3 Provided?	N/A
N/A	X Walk 3 Direction	N/A	N/A	DWS 3 Contrast?	N/A
N/A	X Walk 3 Width (in)	N/A	N/A	DWS 3 Length (in)	N/A
N/A	Road 3 Slope (%)	N/A	N/A	DWS 3 Full Width?	N/A
N/A	Road 3 XSlope (%)	N/A	N/A	DWS 3 Offset (in)	N/A
Yes	Any Obstructions?	N/A	N/A	Storm Grate/Utility Hazard?	N/A
N/A	Obstruction Type		N/A	Storm Grate/Utility Type	
		N/A			N/A
N/A	Surface Condition	Good

Remove & Replace Entire Refuge.
