Access Compliance Report

Public Rights-of-Way

(Island Curb Cuts)

Intersection ID: 28003	Main Street: COMMUNITY_HOUSE_RD	Cross Street: WILLOW_ROCK_DR	Location: E
ADA ID: C544AA72FB2E	Curb Cut Type: MedianRefuge2	Initial Pass/Fail: Fail	Overall Compliance: No
Codes/Mitigation Info/Possible Solution		Field Measurements/Component Compliance	
Severity Score: 0

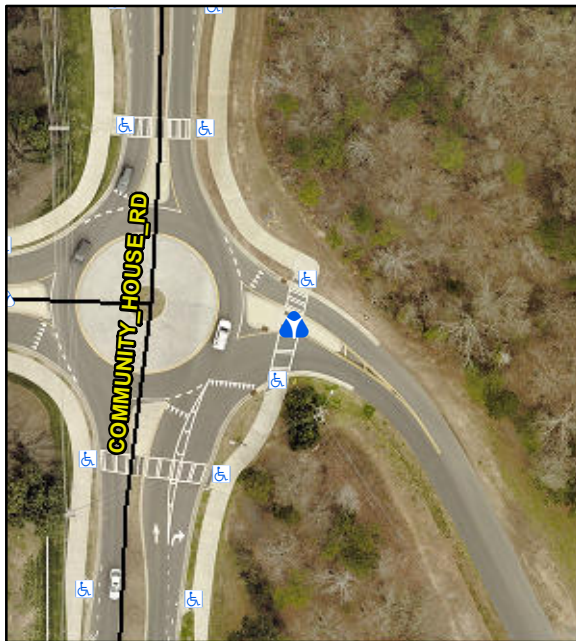
Compliance	Description	Data	Compliance	Description	Data
Yes	Refuge 1 Length (In)	36.5	N/A	Gutter 1 Ponding?	N/A
Yes	Refuge 1 Width (In)	118.0	N/A	Gutter 1 Lip Ht (In)	N/A
Yes	Refuge 1 Slope (%)	0.7	N/A	Gutter 1 Slope (%)	N/A
Yes	Refuge 1 X Slope (%)	2.2	N/A	Gutter 1 X Slope (%)	N/A
N/A	Painted X Walk1?	No	N/A	DWS 1 Provided?	N/A
N/A	X Walk 1 Direction	To SE	N/A	DWS 1 Contrast?	N/A
N/A	X Walk 1 Width (In)	110.0	N/A	DWS 1 Length (In)	N/A
N/A	Road 1 Slope (%)	1.0	N/A	DWS 1 Full Width?	N/A
N/A	Road 1 X Slope (%)	1.1	N/A	DWS 1 Offset (In)	N/A
Yes	Refuge 2 Length (In)	36.5	N/A	Gutter 2 Ponding?	N/A
Yes	Refuge 2 Width (In)	118.0	N/A	Gutter 2 Lip Ht (In)	N/A
Yes	Refuge 2 Slope (%)	1.6	N/A	Gutter 2 Slope (%)	N/A
Yes	Refuge 2 X Slope (%)	2.2	N/A	Gutter 2 X Slope (%)	N/A
N/A	Painted X Walk2?	Yes	N/A	DWS 2 Provided?	N/A
N/A	X Walk 2 Direction	To NW	N/A	DWS 2 Contrast?	N/A
N/A	X Walk 2 Width (In)	112.0	N/A	DWS 2 Length (In)	N/A

N/A	Road 2 Slope (%)	2.2	N/A	DWS 2 Full Width?	N/A
N/A	Road 2 X Slope (%)	3.3	N/A	DWS 2 Offset (In)	N/A
N/A	Refuge 3 Length (in)	N/A	N/A	Gutter 3 Ponding?	N/A
N/A	Refuge 3 Width (in)	N/A	N/A	Gutter 3 Lip Ht (in)	N/A
N/A	Refuge 3 Slope (%)	N/A	N/A	Gutter 3 Slope (%)	N/A
N/A	Refuge 3 XSlope (%)	N/A	N/A	Gutter 3 XSlope (%)	N/A
N/A	Painted X Walk3?	N/A	N/A	DWS 3 Provided?	N/A
N/A	X Walk 3 Direction	N/A	N/A	DWS 3 Contrast?	N/A
N/A	X Walk 3 Width (in)	N/A	N/A	DWS 3 Length (in)	N/A
N/A	Road 3 Slope (%)	N/A	N/A	DWS 3 Full Width?	N/A
N/A	Road 3 XSlope (%)	N/A	N/A	DWS 3 Offset (in)	N/A
Yes	Any Obstructions?	N/A	N/A	Storm Grate/Utility Hazard?	N/A
N/A	Obstruction Type		N/A	Storm Grate/Utility Type	
		N/A			N/A
N/A	Surface Condition	Good

Possible Solutions:

Remove & Replace Entire Refuge.
