Access Compliance Report

Public Rights-of-Way

(Island Curb Cuts)

Intersection ID: 53758	Main Street: PROSPERITY RIDGE RD	Cross Street: JOHNSTON OEHLER RD	Location: N
ADA ID: C7456EBDB10B	Curb Cut Type: MedianRefuge2	Initial Pass/Fail: Fail	Overall Compliance: No
Severity Score: 1.25			
Codes/Mitigation Info/Possible Solution		Field Measurements/Component Compliance

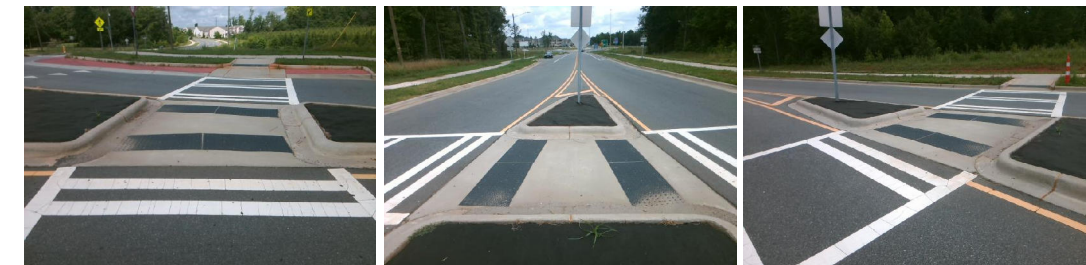
Compliance	Description	Data	Compliance	Description	Data
Yes	Refuge 1 Length (In)	46.0	N/A	Gutter 1 Ponding?	N/A
Yes	Refuge 1 Width (In)	119.0	N/A	Gutter 1 Lip Ht (In)	N/A
Yes	Refuge 1 Slope (%)	2.4	N/A	Gutter 1 Slope (%)	N/A
Yes	Refuge 1 X Slope (%)	3.7	N/A	Gutter 1 X Slope (%)	N/A
N/A	Painted X Walk1?	Yes	N/A	DWS 1 Provided?	N/A
N/A	X Walk 1 Direction	To E	N/A	DWS 1 Contrast?	N/A
N/A	X Walk 1 Width (In)	112.5	N/A	DWS 1 Length (In)	N/A
N/A	Road 1 Slope (%)	2.4	N/A	DWS 1 Full Width?	N/A
N/A	Road 1 X Slope (%)	3.0	N/A	DWS 1 Offset (In)	N/A
Yes	Refuge 2 Length (In)	46.0	N/A	Gutter 2 Ponding?	N/A
Yes	Refuge 2 Width (In)	119.0	N/A	Gutter 2 Lip Ht (In)	N/A
Yes	Refuge 2 Slope (%)	0.5	N/A	Gutter 2 Slope (%)	N/A
Yes	Refuge 2 X Slope (%)	3.8	N/A	Gutter 2 X Slope (%)	N/A
N/A	Painted X Walk2?	Yes	N/A	DWS 2 Provided?	N/A
N/A	X Walk 2 Direction	To W	N/A	DWS 2 Contrast?	N/A
N/A	X Walk 2 Width (In)	112.5	N/A	DWS 2 Length (In)	N/A

N/A	Road 2 Slope (%)	0.7	N/A	DWS 2 Full Width?	N/A
N/A	Road 2 X Slope (%)	2.6	N/A	DWS 2 Offset (In)	N/A
N/A	Refuge 3 Length (in)	N/A	N/A	Gutter 3 Ponding?	N/A
N/A	Refuge 3 Width (in)	N/A	N/A	Gutter 3 Lip Ht (in)	N/A
N/A	Refuge 3 Slope (%)	N/A	N/A	Gutter 3 Slope (%)	N/A
N/A	Refuge 3 XSlope (%)	N/A	N/A	Gutter 3 XSlope (%)	N/A
N/A	Painted X Walk3?	No	N/A	DWS 3 Provided?	N/A
N/A	X Walk 3 Direction	N/A	N/A	DWS 3 Contrast?	N/A
N/A	X Walk 3 Width (in)	N/A	N/A	DWS 3 Length (in)	N/A
N/A	Road 3 Slope (%)	N/A	N/A	DWS 3 Full Width?	N/A
N/A	Road 3 XSlope (%)	N/A	N/A	DWS 3 Offset (in)	N/A
Yes	Any Obstructions?	N/A	N/A	Storm Grate/Utility Hazard?	N/A
N/A	Obstruction Type		N/A	Storm Grate/Utility Type	
		N/A			N/A
N/A	Surface Condition	Good

Possible Solutions:

Remove & Replace Entire Refuge.
