Access Compliance Report

Public Rights-of-Way

(Island Curb Cuts)

Intersection ID: 51702	Main Street: PROSPERITY_RIDGE_RD	Cross Street: N/A	Location: N
ADA ID: C797282F0CE7	Curb Cut Type: MedianRefuge2	Initial Pass/Fail: Pass	Overall Compliance: No
			Severity Score: 15

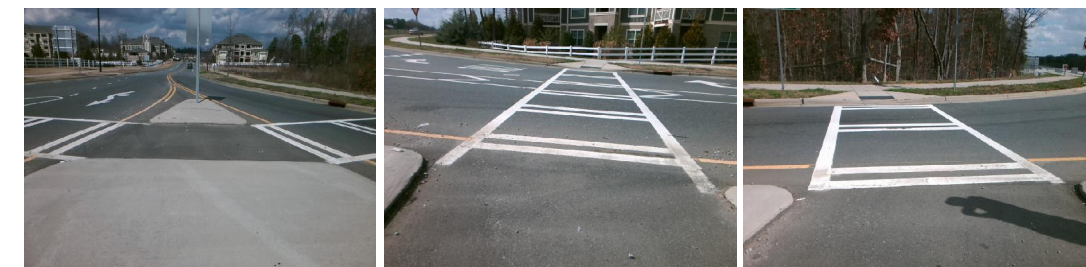
Compliance	Description	Data	Compliance	Description	Data
Yes	Refuge 1 Length (In)	54.0	Yes	Gutter 1 Ponding?	No
Yes	Refuge 1 Width (In)	118.0	Yes	Gutter 1 Lip Ht (In)	0.0
Yes	Refuge 1 Slope (%)	0.7	Yes	Gutter 1 Slope (%)	0.9
Yes	Refuge 1 X Slope (%)	1.8	Yes	Gutter 1 X Slope (%)	.19
N/A	Painted X Walk1?	Yes	No	DWS 1 Provided?	No
N/A	X Walk 1 Direction	To W	N/A	DWS 1 Contrast?	No
N/A	X Walk 1 Width (In)	103.0	N/A	DWS 1 Length (In)	N/A
N/A	Road 1 Slope (%)	2.3	N/A	DWS 1 Full Width?	No
N/A	Road 1 X Slope (%)	1.0	N/A	DWS 1 Offset (In)	N/A
Yes	Refuge 2 Length (In)	54.0	Yes	Gutter 2 Ponding?	No
Yes	Refuge 2 Width (In)	118.0	Yes	Gutter 2 Lip Ht (In)	0.0
Yes	Refuge 2 Slope (%)	0.2	Yes	Gutter 2 Slope (%)	1.5
Yes	Refuge 2 X Slope (%)	1.4	Yes	Gutter 2 X Slope (%)	1.1
N/A	Painted X Walk2?	Yes	No	DWS 2 Provided?	No
N/A	X Walk 2 Direction	To E	N/A	DWS 2 Contrast?	No
N/A	X Walk 2 Width (In)	103.0	N/A	DWS 2 Length (In)	N/A

N/A	Road 2 Slope (%)	0.9	N/A	DWS 2 Full Width?	No
N/A	Road 2 X Slope (%)	2.0	N/A	DWS 2 Offset (In)	N/A
N/A	Refuge 3 Length (in)	N/A	N/A	Gutter 3 Ponding?	N/A
N/A	Refuge 3 Width (in)	N/A	N/A	Gutter 3 Lip Ht (in)	N/A
N/A	Refuge 3 Slope (%)	N/A	N/A	Gutter 3 Slope (%)	N/A
N/A	Refuge 3 XSlope (%)	N/A	N/A	Gutter 3 XSlope (%)	N/A
N/A	Painted X Walk3?	No	N/A	DWS 3 Provided?	N/A
N/A	X Walk 3 Direction	N/A	N/A	DWS 3 Contrast?	N/A
N/A	X Walk 3 Width (in)	N/A	N/A	DWS 3 Length (in)	N/A
N/A	Road 3 Slope (%)	N/A	N/A	DWS 3 Full Width?	N/A
N/A	Road 3 XSlope (%)	N/A	N/A	DWS 3 Offset (in)	N/A
Yes	Any Obstructions?	No	N/A	Storm Grate/Utility Hazard?	No
N/A	Obstruction Type		N/A	Storm Grate/Utility Type	
		N/A			N/A
N/A	Surface Condition	Good

Install Detectable Warning System.
