# Access Compliance Report

## Public Rights-of-Way

### (Island Curb Cuts)

Intersection ID: 26246	Main Street: PROVIDENCE_RD	Cross Street: RAINTREE_LN	Location:	W
ADA ID: C8823095DB93	Curb Cut Type: MedianRefuge2	Initial Pass/Fail: Fail	Overall Compliance: No	Severity Score: 10
Codes/Mitigation Info/Possible Solution		Field Measurements/Component Compliance

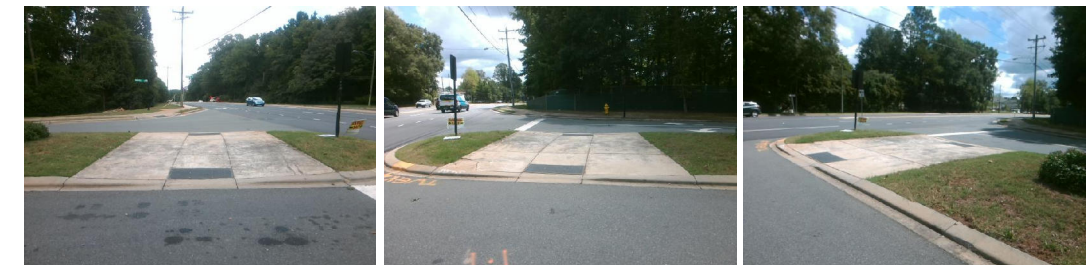
Compliance	Description	Data	Compliance	Description	Data
Yes	Refuge 1 Length (In)	118.5	N/A	Gutter 1 Ponding?	N/A
No	Refuge 1 Width (In)	50.0	N/A	Gutter 1 Lip Ht (In)	N/A
Yes	Refuge 1 Slope (%)	4.6	N/A	Gutter 1 Slope (%)	N/A
Yes	Refuge 1 X Slope (%)	4.6	N/A	Gutter 1 X Slope (%)	N/A
N/A	Painted X Walk1?	No	N/A	DWS 1 Provided?	N/A
N/A	X Walk 1 Direction	To N	N/A	DWS 1 Contrast?	N/A
N/A	X Walk 1 Width (In)	N/A	N/A	DWS 1 Length (In)	N/A
N/A	Road 1 Slope (%)	4.8	N/A	DWS 1 Full Width?	N/A
N/A	Road 1 X Slope (%)	0.9	N/A	DWS 1 Offset (In)	N/A
Yes	Refuge 2 Length (In)	118.5	N/A	Gutter 2 Ponding?	N/A
No	Refuge 2 Width (In)	50.0	N/A	Gutter 2 Lip Ht (In)	N/A
Yes	Refuge 2 Slope (%)	2.0	N/A	Gutter 2 Slope (%)	N/A
Yes	Refuge 2 X Slope (%)	4.0	N/A	Gutter 2 X Slope (%)	N/A
N/A	Painted X Walk2?	No	N/A	DWS 2 Provided?	N/A
N/A	X Walk 2 Direction	To S	N/A	DWS 2 Contrast?	N/A
N/A	X Walk 2 Width (In)	N/A	N/A	DWS 2 Length (In)	N/A

N/A	Road 2 Slope (%)	3.3	N/A	DWS 2 Full Width?	N/A
N/A	Road 2 X Slope (%)	2.0	N/A	DWS 2 Offset (In)	N/A
N/A	Refuge 3 Length (in)	N/A	N/A	Gutter 3 Ponding?	N/A
N/A	Refuge 3 Width (in)	N/A	N/A	Gutter 3 Lip Ht (in)	N/A
N/A	Refuge 3 Slope (%)	N/A	N/A	Gutter 3 Slope (%)	N/A
N/A	Refuge 3 XSlope (%)	N/A	N/A	Gutter 3 XSlope (%)	N/A
N/A	Painted X Walk3?	N/A	N/A	DWS 3 Provided?	N/A
N/A	X Walk 3 Direction	N/A	N/A	DWS 3 Contrast?	N/A
N/A	X Walk 3 Width (in)	N/A	N/A	DWS 3 Length (in)	N/A
N/A	Road 3 Slope (%)	N/A	N/A	DWS 3 Full Width?	N/A
N/A	Road 3 XSlope (%)	N/A	N/A	DWS 3 Offset (in)	N/A
Yes	Any Obstructions?	N/A	N/A	Storm Grate/Utility Hazard?	N/A
N/A	Obstruction Type		N/A	Storm Grate/Utility Type	
		N/A			N/A
N/A	Surface Condition	Good

**Remove & Replace Entire Refuge.**
