Access Compliance Report

Public Rights-of-Way

(Island Curb Cuts)

Intersection ID: 47099	Main Street: GALLERIA_BV	Cross Street: N/A	Location: NE
ADA ID: C953EF18C98D	Curb Cut Type: MedianRefuge2	Initial Pass/Fail: Pass	Overall Compliance: No
Codes/Mitigation Info/Possible Solution		Field Measurements/Component Compliance

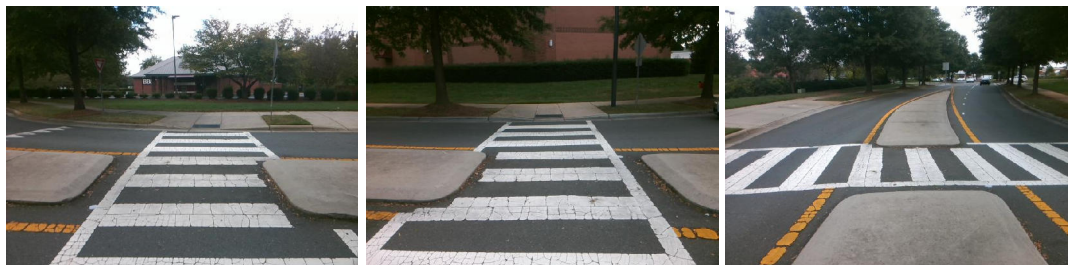
Compliance	Description	Data	Compliance	Description	Data
Yes	Refuge 1 Length (In)	41.5	Yes	Gutter 1 Ponding?	No
Yes	Refuge 1 Width (In)	120.0	Yes	Gutter 1 Lip Ht (In)	0.0
Yes	Refuge 1 Slope (%)	3.0	Yes	Gutter 1 Slope (%)	2.0
Yes	Refuge 1 X Slope (%)	0.1	Yes	Gutter 1 X Slope (%)	1.1
N/A	Painted X Walk1?	Yes	No	DWS 1 Provided?	No
N/A	X Walk 1 Direction	To SE	N/A	DWS 1 Contrast?	No
N/A	X Walk 1 Width (In)	111.0	N/A	DWS 1 Length (In)	N/A
N/A	Road 1 Slope (%)	0.9	N/A	DWS 1 Full Width?	No
N/A	Road 1 X Slope (%)	1.4	N/A	DWS 1 Offset (In)	N/A
Yes	Refuge 2 Length (In)	41.5	Yes	Gutter 2 Ponding?	No
Yes	Refuge 2 Width (In)	120.0	Yes	Gutter 2 Lip Ht (In)	0.0
Yes	Refuge 2 Slope (%)	2.3	Yes	Gutter 2 Slope (%)	2.2
Yes	Refuge 2 X Slope (%)	0.2	Yes	Gutter 2 X Slope (%)	0.4
N/A	Painted X Walk2?	Yes	No	DWS 2 Provided?	No
N/A	X Walk 2 Direction	To NW	N/A	DWS 2 Contrast?	No
N/A	X Walk 2 Width (In)	109.0	N/A	DWS 2 Length (In)	N/A

N/A	Road 2 Slope (%)	0.5	N/A	DWS 2 Full Width?	No
N/A	Road 2 X Slope (%)	2.4	N/A	DWS 2 Offset (In)	N/A
N/A	Refuge 3 Length (in)	N/A	N/A	Gutter 3 Ponding?	N/A
N/A	Refuge 3 Width (in)	N/A	N/A	Gutter 3 Lip Ht (in)	N/A
N/A	Refuge 3 Slope (%)	N/A	N/A	Gutter 3 Slope (%)	N/A
N/A	Refuge 3 XSlope (%)	N/A	N/A	Gutter 3 XSlope (%)	N/A
N/A	Painted X Walk3?	N/A	N/A	DWS 3 Provided?	N/A
N/A	X Walk 3 Direction	N/A	N/A	DWS 3 Contrast?	N/A
N/A	X Walk 3 Width (in)	N/A	N/A	DWS 3 Length (in)	N/A
N/A	Road 3 Slope (%)	N/A	N/A	DWS 3 Full Width?	N/A
N/A	Road 3 XSlope (%)	N/A	N/A	DWS 3 Offset (in)	N/A
Yes	Any Obstructions?	N/A	N/A	Storm Grate/Utility Hazard?	No
N/A	Obstruction Type		N/A	Storm Grate/Utility Type	
		N/A			N/A
N/A	Surface Condition	Good

Possible Solutions:

Install Detectable Warning System.
