Access Compliance Report

Public Rights-of-Way

(Island Curb Cuts)

Intersection ID: 11423	Main Street: S_SUMMIT_AV	Cross Street: W_4TH_ST_EXT	Location: W
ADA ID: CB796AA49FD9	Curb Cut Type: MedianRefuge2	Initial Pass/Fail: Fail	Overall Compliance: No
Severity Score: 0			
Codes/Mitigation Info/Possible Solution		Field Measurements/Component Compliance

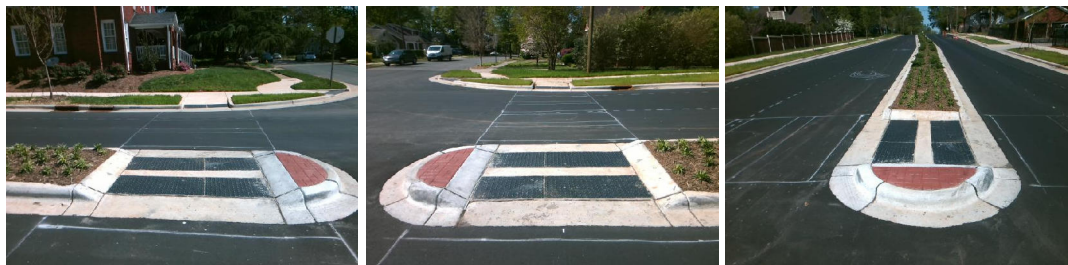
Compliance	Description	Data	Compliance	Description	Data
No	Refuge 1 Length (In)	30.0	N/A	Gutter 1 Ponding?	N/A
Yes	Refuge 1 Width (In)	83.5	N/A	Gutter 1 Lip Ht (In)	N/A
Yes	Refuge 1 Slope (%)	1.4	N/A	Gutter 1 Slope (%)	N/A
Yes	Refuge 1 X Slope (%)	1.9	N/A	Gutter 1 X Slope (%)	N/A
N/A	Painted X Walk1?	No	N/A	DWS 1 Provided?	N/A
N/A	X Walk 1 Direction	To NE	N/A	DWS 1 Contrast?	N/A
N/A	X Walk 1 Width (In)	N/A	N/A	DWS 1 Length (In)	N/A
N/A	Road 1 Slope (%)	2.7	N/A	DWS 1 Full Width?	N/A
N/A	Road 1 X Slope (%)	1.1	N/A	DWS 1 Offset (In)	N/A
No	Refuge 2 Length (In)	30.0	N/A	Gutter 2 Ponding?	N/A
Yes	Refuge 2 Width (In)	83.5	N/A	Gutter 2 Lip Ht (In)	N/A
Yes	Refuge 2 Slope (%)	1.9	N/A	Gutter 2 Slope (%)	N/A
Yes	Refuge 2 X Slope (%)	3.5	N/A	Gutter 2 X Slope (%)	N/A
N/A	Painted X Walk2?	No	N/A	DWS 2 Provided?	N/A
N/A	X Walk 2 Direction	To SW	N/A	DWS 2 Contrast?	N/A
N/A	X Walk 2 Width (In)	N/A	N/A	DWS 2 Length (In)	N/A

N/A	Road 2 Slope (%)	4.6	N/A	DWS 2 Full Width?	N/A
N/A	Road 2 X Slope (%)	2.5	N/A	DWS 2 Offset (In)	N/A
N/A	Refuge 3 Length (in)	N/A	N/A	Gutter 3 Ponding?	N/A
N/A	Refuge 3 Width (in)	N/A	N/A	Gutter 3 Lip Ht (in)	N/A
N/A	Refuge 3 Slope (%)	N/A	N/A	Gutter 3 Slope (%)	N/A
N/A	Refuge 3 XSlope (%)	N/A	N/A	Gutter 3 XSlope (%)	N/A
N/A	Painted X Walk3?	N/A	N/A	DWS 3 Provided?	N/A
N/A	X Walk 3 Direction	N/A	N/A	DWS 3 Contrast?	N/A
N/A	X Walk 3 Width (in)	N/A	N/A	DWS 3 Length (in)	N/A
N/A	Road 3 Slope (%)	N/A	N/A	DWS 3 Full Width?	N/A
N/A	Road 3 XSlope (%)	N/A	N/A	DWS 3 Offset (in)	N/A
Yes	Any Obstructions?	N/A	N/A	Storm Grate/Utility Hazard?	N/A
N/A	Obstruction Type		N/A	Storm Grate/Utility Type	
		N/A			N/A
N/A	Surface Condition	Good

Remove & Replace Entire Refuge.
