# Access Compliance Report

## Public Rights-of-Way

### (Island Curb Cuts)

Intersection ID: 14466	Main Street: W_TYVOLA_RD	Cross Street: RICHARD_ST	Location: S
ADA ID: CB97CA72287A	Curb Cut Type: MedianRefuge2	Initial Pass/Fail: Fail	Overall Compliance: No
Codes/Mitigation Info/Possible Solution		Field Measurements/Component Compliance

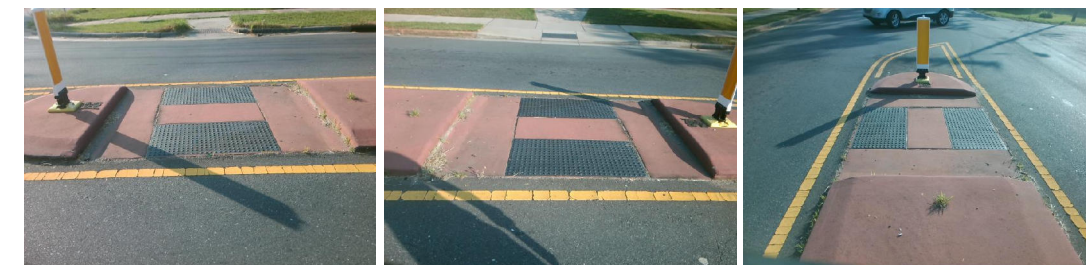
Compliance	Description	Data	Compliance	Description	Data
Yes	Refuge 1 Length (In)	36.0	N/A	Gutter 1 Ponding?	N/A
Yes	Refuge 1 Width (In)	96.0	N/A	Gutter 1 Lip Ht (In)	N/A
Yes	Refuge 1 Slope (%)	0.2	N/A	Gutter 1 Slope (%)	N/A
Yes	Refuge 1 X Slope (%)	3.0	N/A	Gutter 1 X Slope (%)	N/A
N/A	Painted X Walk1?	No	N/A	DWS 1 Provided?	N/A
N/A	X Walk 1 Direction	To W	N/A	DWS 1 Contrast?	N/A
N/A	X Walk 1 Width (In)	N/A	N/A	DWS 1 Length (In)	N/A
N/A	Road 1 Slope (%)	3.0	N/A	DWS 1 Full Width?	N/A
N/A	Road 1 X Slope (%)	3.1	N/A	DWS 1 Offset (In)	N/A
Yes	Refuge 2 Length (In)	36.0	N/A	Gutter 2 Ponding?	N/A
Yes	Refuge 2 Width (In)	96.0	N/A	Gutter 2 Lip Ht (In)	N/A
Yes	Refuge 2 Slope (%)	0.9	N/A	Gutter 2 Slope (%)	N/A
Yes	Refuge 2 X Slope (%)	3.6	N/A	Gutter 2 X Slope (%)	N/A
N/A	Painted X Walk2?	No	N/A	DWS 2 Provided?	N/A
N/A	X Walk 2 Direction	To E	N/A	DWS 2 Contrast?	N/A
N/A	X Walk 2 Width (In)	N/A	N/A	DWS 2 Length (In)	N/A

N/A	Road 2 Slope (%)	2.8	N/A	DWS 2 Full Width?	N/A
N/A	Road 2 X Slope (%)	3.6	N/A	DWS 2 Offset (In)	N/A
N/A	Refuge 3 Length (in)	N/A	N/A	Gutter 3 Ponding?	N/A
N/A	Refuge 3 Width (in)	N/A	N/A	Gutter 3 Lip Ht (in)	N/A
N/A	Refuge 3 Slope (%)	N/A	N/A	Gutter 3 Slope (%)	N/A
N/A	Refuge 3 XSlope (%)	N/A	N/A	Gutter 3 XSlope (%)	N/A
N/A	Painted X Walk3?	N/A	N/A	DWS 3 Provided?	N/A
N/A	X Walk 3 Direction	N/A	N/A	DWS 3 Contrast?	N/A
N/A	X Walk 3 Width (in)	N/A	N/A	DWS 3 Length (in)	N/A
N/A	Road 3 Slope (%)	N/A	N/A	DWS 3 Full Width?	N/A
N/A	Road 3 XSlope (%)	N/A	N/A	DWS 3 Offset (in)	N/A
Yes	Any Obstructions?	N/A	N/A	Storm Grate/Utility Hazard?	N/A
N/A	Obstruction Type		N/A	Storm Grate/Utility Type	
		N/A			N/A
N/A	Surface Condition	Good

**Remove & Replace Entire Refuge.**
