Access Compliance Report

Public Rights-of-Way

(Island Curb Cuts)

| Intersection ID: 8157 | Main Street: N_TRYON_ST | Cross Street: ORR_RD | Location: S |

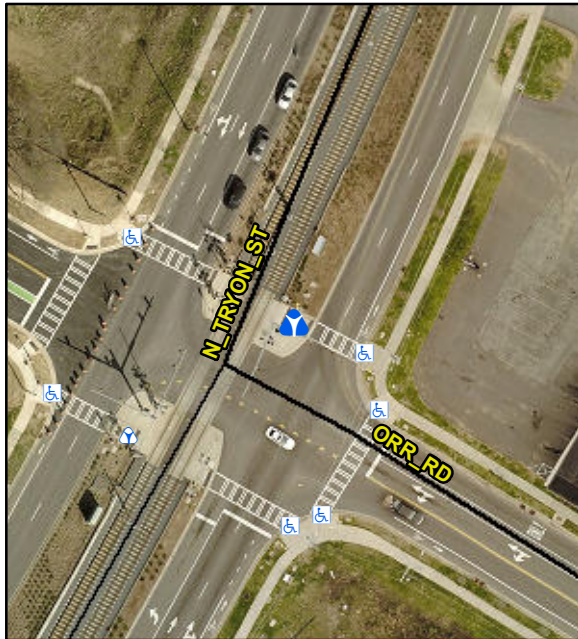
| ADA ID: CE21C91FCE55 | Curb Cut Type: MedianRefuge2 | Initial Pass/Fail: Pass | Overall Compliance: No |

| Compliance | Description | Data | Compliance | Description | Data |
|---|---|---|---|---|---|
| N/A | Road 1 X Slope (%) | 2.9 | No | DWS 1 Offset (In) | 42.0 |

Possible Solutions:

Remove & Replace Detectable Warning System.
