Access Compliance Report

Public Rights-of-Way

(Island Curb Cuts)

| Intersection ID: 22317 | Main Street: SHARON_RD | Cross Street: SHARON_ACRES_RD | Location: W |

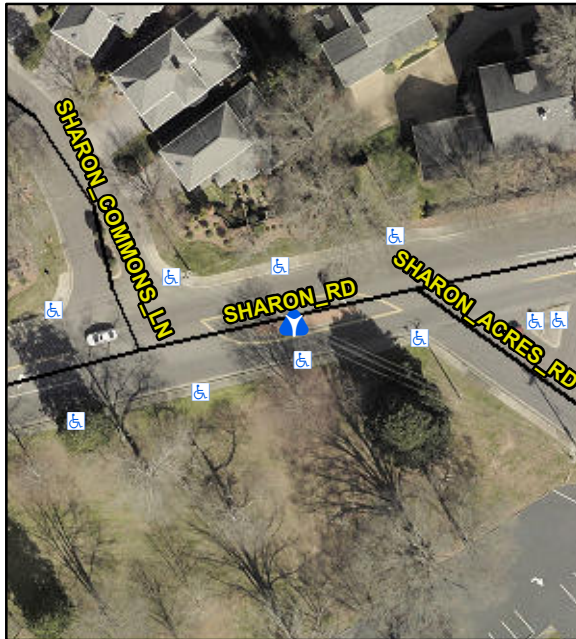
| ADA ID: CE80BAE28590 | Curb Cut Type: MedianRefuge2 | Initial Pass/Fail: Fail | Overall Compliance: No |
| Severity Score: 1.25 | | | |

Possible Solutions:

Remove & Replace Entire Refuge.

Total Cost: \$ 3000.00
