Access Compliance Report

Public Rights-of-Way

(Island Curb Cuts)

Intersection ID: 12448	Main Street: HOLTON_AV	Cross Street: WILKINSON_BV	Location: E
ADA ID: CEA5DA6CABB6	Curb Cut Type: MedianRefuge2	Initial Pass/Fail: Fail	Overall Compliance: No
Codes/Mitigation Info/Possible Solution		Field Measurements/Component Compliance	
Severity Score: 8.75

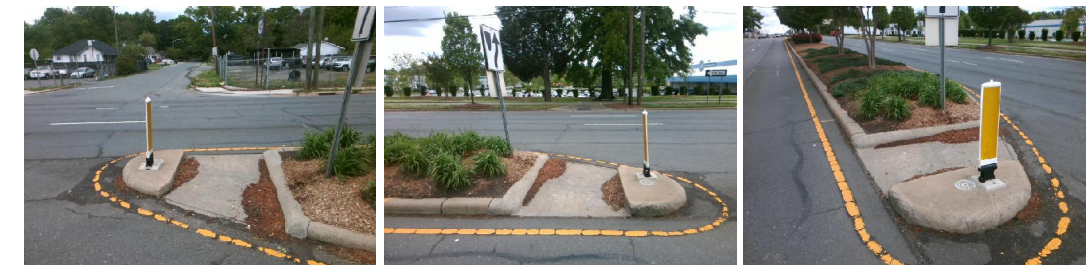
Compliance	Description	Data	Compliance	Description	Data
No	Refuge 1 Length (In)	35.0	N/A	Gutter 1 Ponding?	N/A
No	Refuge 1 Width (In)	56.0	N/A	Gutter 1 Lip Ht (In)	N/A
Yes	Refuge 1 Slope (%)	0.8	N/A	Gutter 1 Slope (%)	N/A
Yes	Refuge 1 X Slope (%)	2.6	N/A	Gutter 1 X Slope (%)	N/A
N/A	Painted X Walk1?	No	N/A	DWS 1 Provided?	N/A
N/A	X Walk 1 Direction	To N	N/A	DWS 1 Contrast?	N/A
N/A	X Walk 1 Width (In)	N/A	N/A	DWS 1 Length (In)	N/A
N/A	Road 1 Slope (%)	2.2	N/A	DWS 1 Full Width?	N/A
N/A	Road 1 X Slope (%)	2.7	N/A	DWS 1 Offset (In)	N/A
No	Refuge 2 Length (In)	35.0	N/A	Gutter 2 Ponding?	N/A
No	Refuge 2 Width (In)	56.0	N/A	Gutter 2 Lip Ht (In)	N/A
Yes	Refuge 2 Slope (%)	0.2	N/A	Gutter 2 Slope (%)	N/A
Yes	Refuge 2 X Slope (%)	1.9	N/A	Gutter 2 X Slope (%)	N/A
N/A	Painted X Walk2?	No	N/A	DWS 2 Provided?	N/A
N/A	X Walk 2 Direction	To S	N/A	DWS 2 Contrast?	N/A
N/A	X Walk 2 Width (In)	N/A	N/A	DWS 2 Length (In)	N/A
N/A	Road 2 Slope (%)	3.0	N/A	DWS 2 Full Width?	N/A

N/A	Road 2 X Slope (%)	3.6	N/A	DWS 2 Offset (In)	N/A
N/A	Refuge 3 Length (in)	N/A	N/A	Gutter 3 Ponding?	N/A
N/A	Refuge 3 Width (in)	N/A	N/A	Gutter 3 Lip Ht (in)	N/A
N/A	Refuge 3 Slope (%)	N/A	N/A	Gutter 3 Slope (%)	N/A
N/A	Refuge 3 XSlope (%)	N/A	N/A	Gutter 3 XSlope (%)	N/A
N/A	Painted X Walk3?	N/A	N/A	DWS 3 Provided?	N/A
N/A	X Walk 3 Direction	N/A	N/A	DWS 3 Contrast?	N/A
N/A	X Walk 3 Width (in)	N/A	N/A	DWS 3 Length (in)	N/A
N/A	Road 3 Slope (%)	N/A	N/A	DWS 3 Full Width?	N/A
N/A	Road 3 XSlope (%)	N/A	N/A	DWS 3 Offset (in)	N/A
Yes	Any Obstructions?	N/A	N/A	Storm Grate/Utility Hazard?	N/A
N/A	Obstruction Type		N/A	Storm Grate/Utility Type	
		N/A			N/A
N/A	Surface Condition	Good

Remove & Replace Entire Refuge.
