Access Compliance Report

Public Rights-of-Way

(Island Curb Cuts)

Intersection ID: 17739	Main Street: E_WOODLAWN_RD	Cross Street: SOUTH_BV	Location: E
ADA ID: CF6A5C3A32F0	Curb Cut Type: MedianRefuge2	Initial Pass/Fail: Fail	Overall Compliance: No
Codes/Mitigation Info/Possible Solution		Field Measurements/Component Compliance	
Severity Score: 0

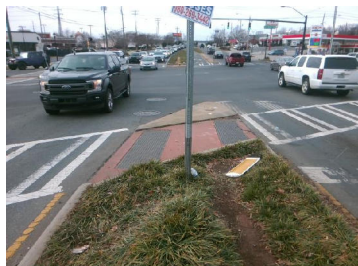
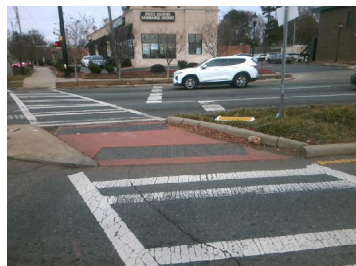
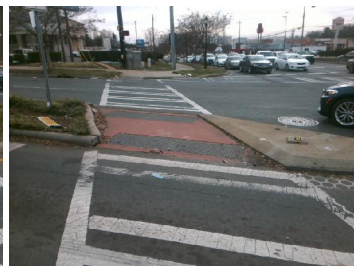
Compliance	Description	Data	Compliance	Description	Data
Yes	Refuge 1 Length (In)	56.0	N/A	Gutter 1 Ponding?	N/A
Yes	Refuge 1 Width (In)	114.0	N/A	Gutter 1 Lip Ht (In)	N/A
Yes	Refuge 1 Slope (%)	1.9	N/A	Gutter 1 Slope (%)	N/A
Yes	Refuge 1 X Slope (%)	3.4	N/A	Gutter 1 X Slope (%)	N/A
N/A	Painted X Walk1?	Yes	N/A	DWS 1 Provided?	N/A
N/A	X Walk 1 Direction	To S	N/A	DWS 1 Contrast?	N/A
N/A	X Walk 1 Width (In)	120.0	N/A	DWS 1 Length (In)	N/A
N/A	Road 1 Slope (%)	4.6	N/A	DWS 1 Full Width?	N/A
N/A	Road 1 X Slope (%)	3.1	N/A	DWS 1 Offset (In)	N/A
Yes	Refuge 2 Length (In)	56.0	N/A	Gutter 2 Ponding?	N/A
Yes	Refuge 2 Width (In)	114.0	N/A	Gutter 2 Lip Ht (In)	N/A
Yes	Refuge 2 Slope (%)	0.4	N/A	Gutter 2 Slope (%)	N/A
Yes	Refuge 2 X Slope (%)	2.8	N/A	Gutter 2 X Slope (%)	N/A
N/A	Painted X Walk2?	Yes	N/A	DWS 2 Provided?	N/A
N/A	X Walk 2 Direction	To N	N/A	DWS 2 Contrast?	N/A
N/A	X Walk 2 Width (In)	116.0	N/A	DWS 2 Length (In)	N/A

N/A	Road 2 Slope (%)	3.9	N/A	DWS 2 Full Width?	N/A
N/A	Road 2 X Slope (%)	1.9	N/A	DWS 2 Offset (In)	N/A
N/A	Refuge 3 Length (in)	N/A	N/A	Gutter 3 Ponding?	N/A
N/A	Refuge 3 Width (in)	N/A	N/A	Gutter 3 Lip Ht (in)	N/A
N/A	Refuge 3 Slope (%)	N/A	N/A	Gutter 3 Slope (%)	N/A
N/A	Refuge 3 XSlope (%)	N/A	N/A	Gutter 3 XSlope (%)	N/A
N/A	Painted X Walk3?	N/A	N/A	DWS 3 Provided?	N/A
N/A	X Walk 3 Direction	N/A	N/A	DWS 3 Contrast?	N/A
N/A	X Walk 3 Width (in)	N/A	N/A	DWS 3 Length (in)	N/A
N/A	Road 3 Slope (%)	N/A	N/A	DWS 3 Full Width?	N/A
N/A	Road 3 XSlope (%)	N/A	N/A	DWS 3 Offset (in)	N/A
Yes	Any Obstructions?	N/A	N/A	Storm Grate/Utility Hazard?	N/A
N/A	Obstruction Type		N/A	Storm Grate/Utility Type	
		N/A			N/A
N/A	Surface Condition	Good

Possible Solutions:

Remove & Replace Entire Refuge.
