Access Compliance Report

Public Rights-of-Way

(Island Curb Cuts)

| Intersection ID: 7091 | Main Street: BROOKSHIRE_BV | Cross Street: HOVIS_RD | Location: E |

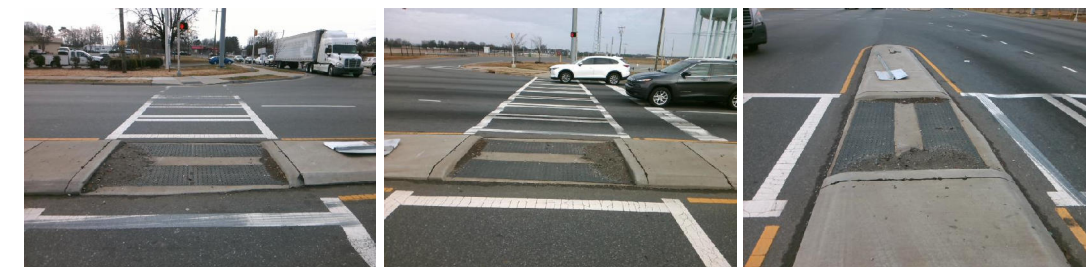
| Compliance | Description | Data | Compliance | Description | Data |
|---|---|---|---|---|---|
| No | Refuge 1 Length (In) | 34.0 | N/A | Gutter 1 Ponding? | N/A |
| No | Refuge 2 Length (In) | 34.0 | N/A | Gutter 2 Ponding? | N/A |

Remove & Replace Entire Refuge.
