Access Compliance Report

Public Rights-of-Way

(Island Curb Cuts)

Intersection ID: 7770	Main Street: E_ARROWHEAD_DR	Cross Street: N_TRYON_ST	Location:	N
ADA ID: D357A8A74646	Curb Cut Type: MedianRefuge2	Initial Pass/Fail: Pass	Overall Compliance: No	Severity Score: 15
Codes/Mitigation Info/Possible Solution		Field Measurements/Component Compliance

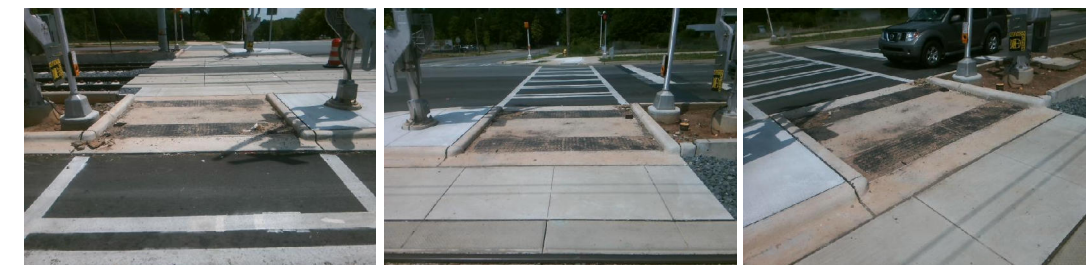
Compliance	Description	Data	Compliance	Description	Data
Yes	Refuge 1 Length (In)	48.0	Yes	Gutter 1 Ponding?	No
Yes	Refuge 1 Width (In)	121.0	No	Gutter 1 Lip Ht (In)	1.0
Yes	Refuge 1 Slope (%)	0.1	Yes	Gutter 1 Slope (%)	1.9
Yes	Refuge 1 X Slope (%)	0.9	Yes	Gutter 1 X Slope (%)	0.1
N/A	Painted X Walk1?	Yes	Yes	DWS 1 Provided?	Yes
N/A	X Walk 1 Direction	To W	Yes	DWS 1 Contrast?	Yes
N/A	X Walk 1 Width (In)	120.0	Yes	DWS 1 Length (In)	24.0
N/A	Road 1 Slope (%)	0.3	Yes	DWS 1 Full Width?	Yes
N/A	Road 1 X Slope (%)	2.4	Yes	DWS 1 Offset (In)	2.0
Yes	Refuge 2 Length (In)	48.0	Yes	Gutter 2 Ponding?	No
Yes	Refuge 2 Width (In)	121.0	Yes	Gutter 2 Lip Ht (In)	0.0
Yes	Refuge 2 Slope (%)	0.7	Yes	Gutter 2 Slope (%)	2.3
Yes	Refuge 2 X Slope (%)	0.0	Yes	Gutter 2 X Slope (%)	0.4
N/A	Painted X Walk2?	No	Yes	DWS 2 Provided?	Yes
N/A	X Walk 2 Direction	To E	Yes	DWS 2 Contrast?	Yes
N/A	X Walk 2 Width (In)	N/A	Yes	DWS 2 Length (In)	24.0

N/A	Road 2 Slope (%)	0.4	Yes	DWS 2 Full Width?	Yes
N/A	Road 2 X Slope (%)	0.1	Yes	DWS 2 Offset (In)	0.0
N/A	Refuge 3 Length (in)	N/A	N/A	Gutter 3 Ponding?	No
N/A	Refuge 3 Width (in)	N/A	N/A	Gutter 3 Lip Ht (in)	N/A
N/A	Refuge 3 Slope (%)	N/A	N/A	Gutter 3 Slope (%)	N/A
N/A	Refuge 3 XSlope (%)	N/A	N/A	Gutter 3 XSlope (%)	N/A
N/A	Painted X Walk3?	No	N/A	DWS 3 Provided?	N/A
N/A	X Walk 3 Direction	N/A	N/A	DWS 3 Contrast?	N/A
N/A	X Walk 3 Width (in)	N/A	N/A	DWS 3 Length (in)	N/A
N/A	Road 3 Slope (%)	N/A	N/A	DWS 3 Full Width?	N/A
N/A	Road 3 XSlope (%)	N/A	N/A	DWS 3 Offset (in)	N/A
Yes	Any Obstructions?	No	N/A	Storm Grate/Utility Hazard?	No
N/A	Obstruction Type		N/A	Storm Grate/Utility Type	
		N/A			N/A
N/A	Surface Condition	Good

Grind Gutter Lip.
