Access Compliance Report

Public Rights-of-Way

(Island Curb Cuts)

| Intersection ID: 48600 | Main Street: GRANDIFLORA_DR | Cross Street: LITTLE_GEM_LN | Location: | N |

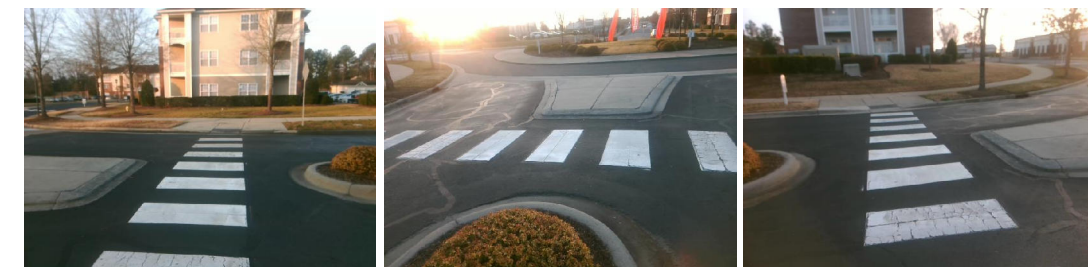
| ADA ID: D682AC35AFDE | Curb Cut Type: MedianRefuge2 | Initial Pass/Fail: Fail | Overall Compliance: No | Severity Score: 0 |

| Compliance | Description | Data | Compliance | Description | Data |
|---|---|---|---|---|---|
| No | Refuge 1 Length (In) | 32.0 | N/A | Gutter 1 Ponding? | N/A |
| No | Refuge 2 Length (In) | 32.0 | N/A | Gutter 2 Ponding? | N/A |

Remove & Replace Entire Refuge.
