# Access Compliance Report

## Public Rights-of-Way

### (Island Curb Cuts)

| Intersection ID: 12779 | Main Street: E_TRADE_ST | Cross Street: S_DAVIDSON_ST | Location: E |

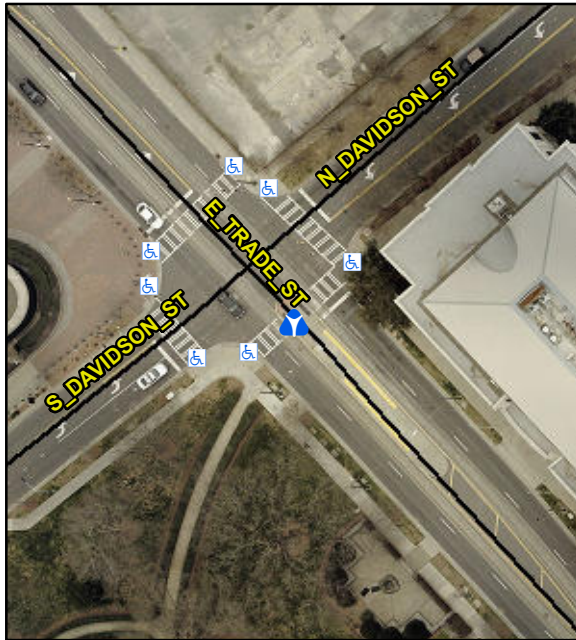
| Compliance | Description | Data | Compliance | Description | Data |
|---|---|---|---|---|---|
| Yes | Refuge 1 Width (In) | 119.0 | No | Gutter 1 Lip Ht (In) | 0.25 |
| Yes | Refuge 2 Width (In) | 119.0 | No | Gutter 2 Lip Ht (In) | 0.25 |

Possible Solutions:

**Grind Gutter Lip.**
