Access Compliance Report

Public Rights-of-Way

(Island Curb Cuts)

Intersection ID: 10022037	Main Street: BRYANT_FARMS_RD	Cross Street: N/A	Location: S
ADA ID: DA8CCC07D807	Curb Cut Type: MedianRefuge2	Initial Pass/Fail: Fail	Overall Compliance: No
Codes/Mitigation Info/Possible Solution		Field Measurements/Component Compliance

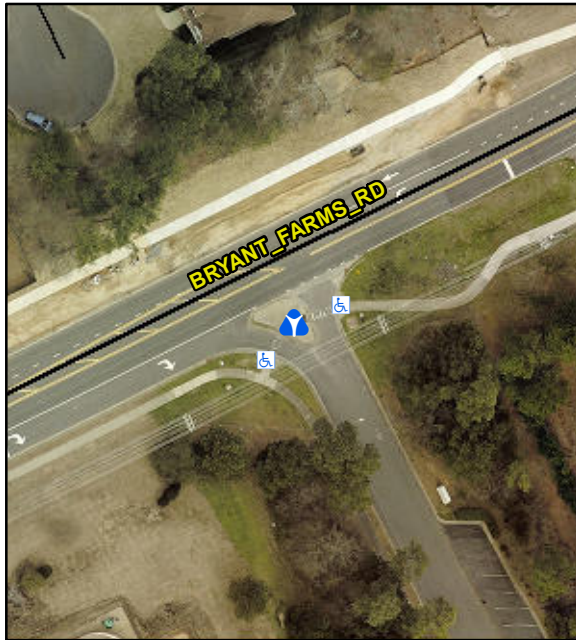
Compliance	Description	Data	Compliance	Description	Data
Yes	Refuge 1 Length (In)	72.5	N/A	Gutter 1 Ponding?	N/A
No	Refuge 1 Width (In)	59.0	N/A	Gutter 1 Lip Ht (In)	N/A
Yes	Refuge 1 Slope (%)	0.4	N/A	Gutter 1 Slope (%)	N/A
Yes	Refuge 1 X Slope (%)	2.5	N/A	Gutter 1 X Slope (%)	N/A
N/A	Painted X Walk1?	Yes	N/A	DWS 1 Provided?	N/A
N/A	X Walk 1 Direction	To SE	N/A	DWS 1 Contrast?	N/A
N/A	X Walk 1 Width (In)	48.0	N/A	DWS 1 Length (In)	N/A
N/A	Road 1 Slope (%)	0.5	N/A	DWS 1 Full Width?	N/A
N/A	Road 1 X Slope (%)	2.1	N/A	DWS 1 Offset (In)	N/A
Yes	Refuge 2 Length (In)	72.5	N/A	Gutter 2 Ponding?	N/A
No	Refuge 2 Width (In)	59.0	N/A	Gutter 2 Lip Ht (In)	N/A
Yes	Refuge 2 Slope (%)	4.4	N/A	Gutter 2 Slope (%)	N/A
Yes	Refuge 2 X Slope (%)	0.7	N/A	Gutter 2 X Slope (%)	N/A
N/A	Painted X Walk2?	Yes	N/A	DWS 2 Provided?	N/A
N/A	X Walk 2 Direction	To SW	N/A	DWS 2 Contrast?	N/A
N/A	X Walk 2 Width (In)	48.0	N/A	DWS 2 Length (In)	N/A

N/A	Road 2 Slope (%)	0.2	N/A	DWS 2 Full Width?	N/A
N/A	Road 2 X Slope (%)	0.1	N/A	DWS 2 Offset (In)	N/A
N/A	Refuge 3 Length (in)	N/A	N/A	Gutter 3 Ponding?	N/A
N/A	Refuge 3 Width (in)	N/A	N/A	Gutter 3 Lip Ht (in)	N/A
N/A	Refuge 3 Slope (%)	N/A	N/A	Gutter 3 Slope (%)	N/A
N/A	Refuge 3 XSlope (%)	N/A	N/A	Gutter 3 XSlope (%)	N/A
N/A	Painted X Walk3?	N/A	N/A	DWS 3 Provided?	N/A
N/A	X Walk 3 Direction	N/A	N/A	DWS 3 Contrast?	N/A
N/A	X Walk 3 Width (in)	N/A	N/A	DWS 3 Length (in)	N/A
N/A	Road 3 Slope (%)	N/A	N/A	DWS 3 Full Width?	N/A
N/A	Road 3 XSlope (%)	N/A	N/A	DWS 3 Offset (in)	N/A
Yes	Any Obstructions?	N/A	N/A	Storm Grate/Utility Hazard?	N/A
N/A	Obstruction Type		N/A	Storm Grate/Utility Type	
		N/A			N/A
N/A	Surface Condition	Good

Possible Solutions:

Remove & Replace Entire Refuge.
