# Access Compliance Report

## Public Rights-of-Way

### (Island Curb Cuts)

Intersection ID: 52918	Main Street: HOOVER_CREEK_BV	Cross Street: STEELE_CREEK_RD	Location: NW
ADA ID: DAF945C60F4D	Curb Cut Type: MedianRefuge2	Initial Pass/Fail: Fail	Overall Compliance: No
Codes/Mitigation Info/Possible Solution		Field Measurements/Component Compliance	
Severity Score: 10

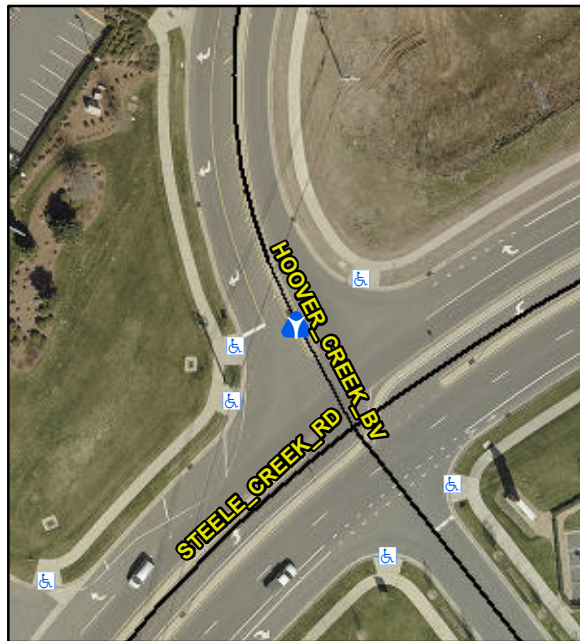
Compliance	Description	Data	Compliance	Description	Data
No	Refuge 1 Length (In)	24.0	N/A	Gutter 1 Ponding?	N/A
No	Refuge 1 Width (In)	48.0	N/A	Gutter 1 Lip Ht (In)	N/A
Yes	Refuge 1 Slope (%)	1.9	N/A	Gutter 1 Slope (%)	N/A
Yes	Refuge 1 X Slope (%)	3.3	N/A	Gutter 1 X Slope (%)	N/A
N/A	Painted X Walk1?	No	N/A	DWS 1 Provided?	N/A
N/A	X Walk 1 Direction	To SW	N/A	DWS 1 Contrast?	N/A
N/A	X Walk 1 Width (In)	N/A	N/A	DWS 1 Length (In)	N/A
N/A	Road 1 Slope (%)	3.6	N/A	DWS 1 Full Width?	N/A
N/A	Road 1 X Slope (%)	2.3	N/A	DWS 1 Offset (In)	N/A
No	Refuge 2 Length (In)	24.0	N/A	Gutter 2 Ponding?	N/A
No	Refuge 2 Width (In)	48.0	N/A	Gutter 2 Lip Ht (In)	N/A
Yes	Refuge 2 Slope (%)	2.4	N/A	Gutter 2 Slope (%)	N/A
Yes	Refuge 2 X Slope (%)	2.3	N/A	Gutter 2 X Slope (%)	N/A
N/A	Painted X Walk2?	No	N/A	DWS 2 Provided?	N/A
N/A	X Walk 2 Direction	To NE	N/A	DWS 2 Contrast?	N/A
N/A	X Walk 2 Width (In)	N/A	N/A	DWS 2 Length (In)	N/A

N/A	Road 2 Slope (%)	2.1	N/A	DWS 2 Full Width?	N/A
N/A	Road 2 X Slope (%)	2.7	N/A	DWS 2 Offset (In)	N/A
N/A	Refuge 3 Length (in)	N/A	N/A	Gutter 3 Ponding?	N/A
N/A	Refuge 3 Width (in)	N/A	N/A	Gutter 3 Lip Ht (in)	N/A
N/A	Refuge 3 Slope (%)	N/A	N/A	Gutter 3 Slope (%)	N/A
N/A	Refuge 3 XSlope (%)	N/A	N/A	Gutter 3 XSlope (%)	N/A
N/A	Painted X Walk3?	N/A	N/A	DWS 3 Provided?	N/A
N/A	X Walk 3 Direction	N/A	N/A	DWS 3 Contrast?	N/A
N/A	X Walk 3 Width (in)	N/A	N/A	DWS 3 Length (in)	N/A
N/A	Road 3 Slope (%)	N/A	N/A	DWS 3 Full Width?	N/A
N/A	Road 3 XSlope (%)	N/A	N/A	DWS 3 Offset (in)	N/A
Yes	Any Obstructions?	N/A	N/A	Storm Grate/Utility Hazard?	N/A
N/A	Obstruction Type		N/A	Storm Grate/Utility Type	
		N/A			N/A
N/A	Surface Condition	Good

**Remove & Replace Entire Refuge.**
