Access Compliance Report

Public Rights-of-Way

(Island Curb Cuts)

Intersection ID: 15201	Main Street: ALBEMARLE_RD	Cross Street: LAWYERS_RD	Location: N
ADA ID: DB06AE1D1358	Curb Cut Type: MedianRefuge2	Initial Pass/Fail: Fail	Overall Compliance: No
Codes/Mitigation Info/Possible Solution		Field Measurements/Component Compliance	
Severity Score: 0

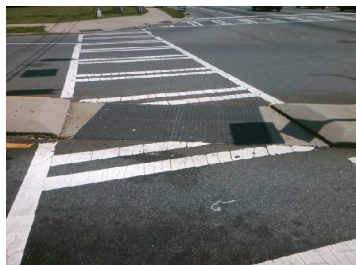
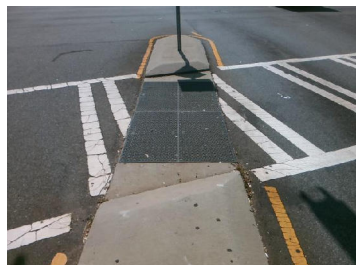
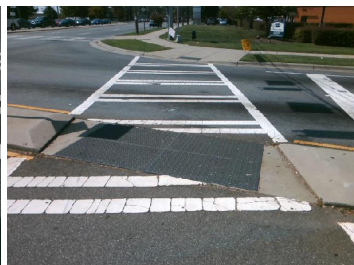
Compliance	Description	Data	Compliance	Description	Data
No	Refuge 1 Length (In)	25.0	N/A	Gutter 1 Ponding?	N/A
Yes	Refuge 1 Width (In)	127.0	N/A	Gutter 1 Lip Ht (In)	N/A
Yes	Refuge 1 Slope (%)	0.4	N/A	Gutter 1 Slope (%)	N/A
Yes	Refuge 1 X Slope (%)	2.5	N/A	Gutter 1 X Slope (%)	N/A
N/A	Painted X Walk1?	Yes	N/A	DWS 1 Provided?	N/A
N/A	X Walk 1 Direction	To SW	N/A	DWS 1 Contrast?	N/A
N/A	X Walk 1 Width (In)	119.0	N/A	DWS 1 Length (In)	N/A
N/A	Road 1 Slope (%)	2.2	N/A	DWS 1 Full Width?	N/A
N/A	Road 1 X Slope (%)	0.9	N/A	DWS 1 Offset (In)	N/A
No	Refuge 2 Length (In)	25.0	N/A	Gutter 2 Ponding?	N/A
Yes	Refuge 2 Width (In)	127.0	N/A	Gutter 2 Lip Ht (In)	N/A
Yes	Refuge 2 Slope (%)	0.5	N/A	Gutter 2 Slope (%)	N/A
Yes	Refuge 2 X Slope (%)	2.7	N/A	Gutter 2 X Slope (%)	N/A
N/A	Painted X Walk2?	Yes	N/A	DWS 2 Provided?	N/A
N/A	X Walk 2 Direction	To NE	N/A	DWS 2 Contrast?	N/A
N/A	X Walk 2 Width (In)	119.0	N/A	DWS 2 Length (In)	N/A

Remove & Replace Entire Refuge.
