Access Compliance Report

Public Rights-of-Way

(Island Curb Cuts)

Intersection ID: 48587	Main Street: STONEY_CREEK_LN	Cross Street: UNIVERSITY_CITY_BV	Location: E
ADA ID: DCAEE19022DF	Curb Cut Type: MedianRefuge2	Initial Pass/Fail: Pass	Overall Compliance: No
Severity Score: 10			
Codes/Mitigation Info/Possible Solution		Field Measurements/Component Compliance

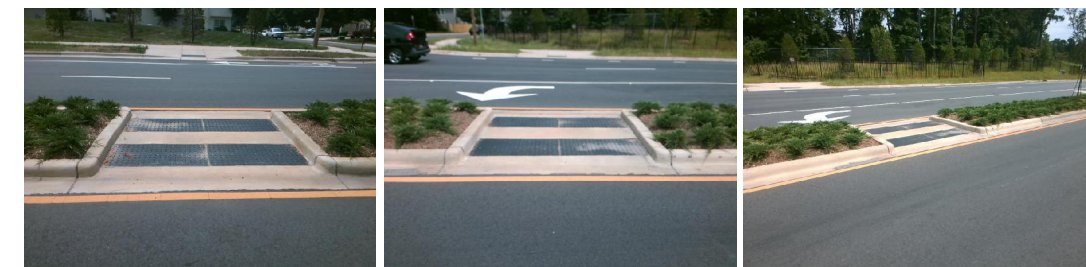
Compliance	Description	Data	Compliance	Description	Data
No	Refuge 1 Length (In)	34.0	Yes	Gutter 1 Ponding?	No
Yes	Refuge 1 Width (In)	94.0	Yes	Gutter 1 Lip Ht (In)	0.0
Yes	Refuge 1 Slope (%)	0.4	No	Gutter 1 Slope (%)	5.8
Yes	Refuge 1 X Slope (%)	1.1	Yes	Gutter 1 X Slope (%)	0.9
N/A	Painted X Walk1?	No	No	DWS 1 Provided?	Yes
N/A	X Walk 1 Direction	To N	N/A	DWS 1 Contrast?	Yes
N/A	X Walk 1 Width (In)	N/A	N/A	DWS 1 Length (In)	24.0
N/A	Road 1 Slope (%)	0.2	N/A	DWS 1 Full Width?	Yes
N/A	Road 1 X Slope (%)	0.2	N/A	DWS 1 Offset (In)	0.0
No	Refuge 2 Length (In)	34.0	Yes	Gutter 2 Ponding?	No
Yes	Refuge 2 Width (In)	94.0	Yes	Gutter 2 Lip Ht (In)	0.0
Yes	Refuge 2 Slope (%)	1.3	Yes	Gutter 2 Slope (%)	2.6
Yes	Refuge 2 X Slope (%)	0.2	Yes	Gutter 2 X Slope (%)	0.8
N/A	Painted X Walk2?	No	No	DWS 2 Provided?	Yes
N/A	X Walk 2 Direction	To S	N/A	DWS 2 Contrast?	Yes
N/A	X Walk 2 Width (In)	N/A	N/A	DWS 2 Length (In)	24.0
N/A	Road 2 Slope (%)	0.6	N/A	DWS 2 Full Width?	Yes

N/A	Road 2 X Slope (%)	2.9	N/A	DWS 2 Offset (In)	0.0
N/A	Refuge 3 Length (in)	N/A	N/A	Gutter 3 Ponding?	No
N/A	Refuge 3 Width (in)	N/A	N/A	Gutter 3 Lip Ht (in)	N/A
N/A	Refuge 3 Slope (%)	N/A	N/A	Gutter 3 Slope (%)	N/A
N/A	Refuge 3 XSlope (%)	N/A	N/A	Gutter 3 XSlope (%)	N/A
N/A	Painted X Walk3?	No	N/A	DWS 3 Provided?	N/A
N/A	X Walk 3 Direction	N/A	N/A	DWS 3 Contrast?	N/A
N/A	X Walk 3 Width (in)	N/A	N/A	DWS 3 Length (in)	N/A
N/A	Road 3 Slope (%)	N/A	N/A	DWS 3 Full Width?	N/A
N/A	Road 3 XSlope (%)	N/A	N/A	DWS 3 Offset (in)	N/A
Yes	Any Obstructions?	No	N/A	Storm Grate/Utility Hazard?	No
N/A	Obstruction Type		N/A	Storm Grate/Utility Type	
		N/A			N/A
N/A	Surface Condition	Good

Possible Solutions:

Remove & Replace Entire Refuge.
Remove & Replace Gutter.
