Access Compliance Report

Public Rights-of-Way

(Island Curb Cuts)

Intersection ID: 48600	Main Street: GRANDIFLORA_DR	Cross Street: LITTLE_GEM_LN	Location:	W
ADA ID: DCC595CBC90B	Curb Cut Type: MedianRefuge2	Initial Pass/Fail: Fail	Overall Compliance: No	Severity Score: 13.75
Codes/Mitigation Info/Possible Solution		Field Measurements/Component Compliance

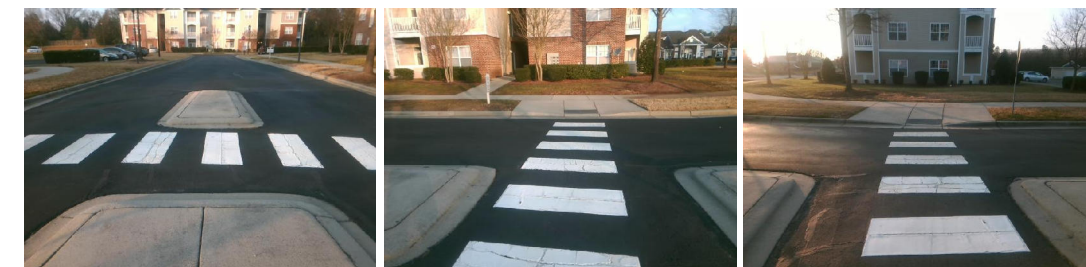
N/A	Road 2 Slope (%)	0.6	N/A	DWS 2 Full Width?	N/A
N/A	Road 2 X Slope (%)	4.3	N/A	DWS 2 Offset (In)	N/A
N/A	Refuge 3 Length (in)	N/A	N/A	Gutter 3 Ponding?	N/A
N/A	Refuge 3 Width (in)	N/A	N/A	Gutter 3 Lip Ht (in)	N/A
N/A	Refuge 3 Slope (%)	N/A	N/A	Gutter 3 Slope (%)	N/A
N/A	Refuge 3 XSlope (%)	N/A	N/A	Gutter 3 XSlope (%)	N/A
N/A	Painted X Walk3?	N/A	N/A	DWS 3 Provided?	N/A
N/A	X Walk 3 Direction	N/A	N/A	DWS 3 Contrast?	N/A
N/A	X Walk 3 Width (in)	N/A	N/A	DWS 3 Length (in)	N/A
N/A	Road 3 Slope (%)	N/A	N/A	DWS 3 Full Width?	N/A
N/A	Road 3 XSlope (%)	N/A	N/A	DWS 3 Offset (in)	N/A
Yes	Any Obstructions?	N/A	N/A	Storm Grate/Utility Hazard?	N/A
N/A	Obstruction Type		N/A	Storm Grate/Utility Type	
		N/A			N/A
N/A	Surface Condition	Good
