# Access Compliance Report

## Public Rights-of-Way

### (Island Curb Cuts)

Intersection ID: 20185	Main Street: FAIRVIEW_RD	Cross Street: PIEDMONT_ROW_DR	Location: W
ADA ID: DE41056607D0	Curb Cut Type: MedianRefuge2	Initial Pass/Fail: Fail	Overall Compliance: No
Severity Score: 1.25			
Codes/Mitigation Info/Possible Solution		Field Measurements/Component Compliance

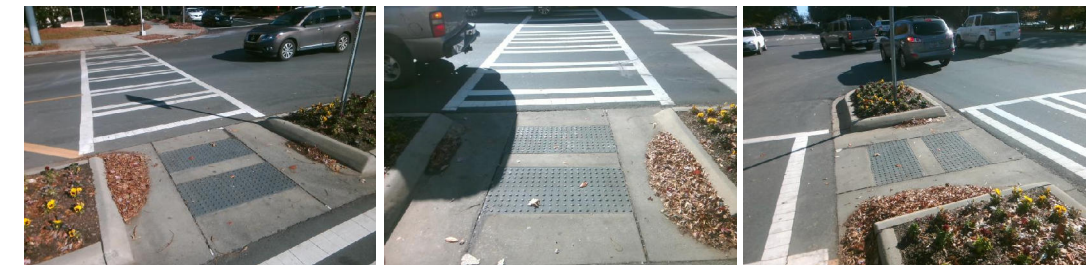
Compliance	Description	Data	Compliance	Description	Data
No	Refuge 1 Length (In)	35.0	N/A	Gutter 1 Ponding?	N/A
Yes	Refuge 1 Width (In)	102.0	N/A	Gutter 1 Lip Ht (In)	N/A
Yes	Refuge 1 Slope (%)	1.1	N/A	Gutter 1 Slope (%)	N/A
Yes	Refuge 1 X Slope (%)	2.7	N/A	Gutter 1 X Slope (%)	N/A
N/A	Painted X Walk1?	Yes	N/A	DWS 1 Provided?	N/A
N/A	X Walk 1 Direction	To NE	N/A	DWS 1 Contrast?	N/A
N/A	X Walk 1 Width (In)	109.0	N/A	DWS 1 Length (In)	N/A
N/A	Road 1 Slope (%)	2.6	N/A	DWS 1 Full Width?	N/A
N/A	Road 1 X Slope (%)	2.4	N/A	DWS 1 Offset (In)	N/A
No	Refuge 2 Length (In)	35.0	N/A	Gutter 2 Ponding?	N/A
Yes	Refuge 2 Width (In)	102.0	N/A	Gutter 2 Lip Ht (In)	N/A
Yes	Refuge 2 Slope (%)	3.3	N/A	Gutter 2 Slope (%)	N/A
Yes	Refuge 2 X Slope (%)	1.3	N/A	Gutter 2 X Slope (%)	N/A
N/A	Painted X Walk2?	Yes	N/A	DWS 2 Provided?	N/A
N/A	X Walk 2 Direction	To SW	N/A	DWS 2 Contrast?	N/A
N/A	X Walk 2 Width (In)	115.0	N/A	DWS 2 Length (In)	N/A

N/A	Road 2 Slope (%)	3.0	N/A	DWS 2 Full Width?	N/A
N/A	Road 2 X Slope (%)	5.1	N/A	DWS 2 Offset (In)	N/A
N/A	Refuge 3 Length (in)	N/A	N/A	Gutter 3 Ponding?	N/A
N/A	Refuge 3 Width (in)	N/A	N/A	Gutter 3 Lip Ht (in)	N/A
N/A	Refuge 3 Slope (%)	N/A	N/A	Gutter 3 Slope (%)	N/A
N/A	Refuge 3 XSlope (%)	N/A	N/A	Gutter 3 XSlope (%)	N/A
N/A	Painted X Walk3?	N/A	N/A	DWS 3 Provided?	N/A
N/A	X Walk 3 Direction	N/A	N/A	DWS 3 Contrast?	N/A
N/A	X Walk 3 Width (in)	N/A	N/A	DWS 3 Length (in)	N/A
N/A	Road 3 Slope (%)	N/A	N/A	DWS 3 Full Width?	N/A
N/A	Road 3 XSlope (%)	N/A	N/A	DWS 3 Offset (in)	N/A
Yes	Any Obstructions?	N/A	N/A	Storm Grate/Utility Hazard?	N/A
N/A	Obstruction Type		N/A	Storm Grate/Utility Type	
		N/A			N/A
N/A	Surface Condition	Good

**Remove & Replace Entire Refuge.**
