Access Compliance Report

Public Rights-of-Way

(Island Curb Cuts)

Intersection ID: 52476	Main Street: WHITEHALL_EXECUTIVE_CENTER_DR	Cross Street: CERNY_DR	Location: NE
ADA ID: DE72D48AA1C9	Curb Cut Type: MedianRefuge2	Initial Pass/Fail: Fail	Overall Compliance: No
Severity Score: 0			
Codes/Mitigation Info/Possible Solution		Field Measurements/Component Compliance

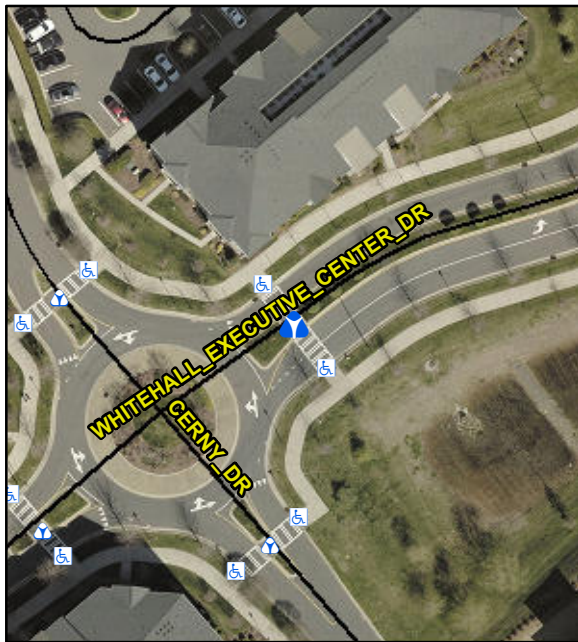
Compliance	Description	Data	Compliance	Description	Data
Yes	Refuge 1 Length (In)	78.0	N/A	Gutter 1 Ponding?	N/A
Yes	Refuge 1 Width (In)	101.0	N/A	Gutter 1 Lip Ht (In)	N/A
Yes	Refuge 1 Slope (%)	0.1	N/A	Gutter 1 Slope (%)	N/A
Yes	Refuge 1 X Slope (%)	4.8	N/A	Gutter 1 X Slope (%)	N/A
N/A	Painted X Walk1?	Yes	N/A	DWS 1 Provided?	N/A
N/A	X Walk 1 Direction	To SE	N/A	DWS 1 Contrast?	N/A
N/A	X Walk 1 Width (In)	113.0	N/A	DWS 1 Length (In)	N/A
N/A	Road 1 Slope (%)	3.5	N/A	DWS 1 Full Width?	N/A
N/A	Road 1 X Slope (%)	1.4	N/A	DWS 1 Offset (In)	N/A
Yes	Refuge 2 Length (In)	78.0	N/A	Gutter 2 Ponding?	N/A
Yes	Refuge 2 Width (In)	101.0	N/A	Gutter 2 Lip Ht (In)	N/A
Yes	Refuge 2 Slope (%)	0.8	N/A	Gutter 2 Slope (%)	N/A
Yes	Refuge 2 X Slope (%)	4.4	N/A	Gutter 2 X Slope (%)	N/A
N/A	Painted X Walk2?	Yes	N/A	DWS 2 Provided?	N/A
N/A	X Walk 2 Direction	To NW	N/A	DWS 2 Contrast?	N/A
N/A	X Walk 2 Width (In)	111.0	N/A	DWS 2 Length (In)	N/A

N/A	Road 2 Slope (%)	3.2	N/A	DWS 2 Full Width?	N/A
N/A	Road 2 X Slope (%)	2.6	N/A	DWS 2 Offset (In)	N/A
N/A	Refuge 3 Length (in)	N/A	N/A	Gutter 3 Ponding?	N/A
N/A	Refuge 3 Width (in)	N/A	N/A	Gutter 3 Lip Ht (in)	N/A
N/A	Refuge 3 Slope (%)	N/A	N/A	Gutter 3 Slope (%)	N/A
N/A	Refuge 3 XSlope (%)	N/A	N/A	Gutter 3 XSlope (%)	N/A
N/A	Painted X Walk3?	N/A	N/A	DWS 3 Provided?	N/A
N/A	X Walk 3 Direction	N/A	N/A	DWS 3 Contrast?	N/A
N/A	X Walk 3 Width (in)	N/A	N/A	DWS 3 Length (in)	N/A
N/A	Road 3 Slope (%)	N/A	N/A	DWS 3 Full Width?	N/A
N/A	Road 3 XSlope (%)	N/A	N/A	DWS 3 Offset (in)	N/A
Yes	Any Obstructions?	N/A	N/A	Storm Grate/Utility Hazard?	N/A
N/A	Obstruction Type		N/A	Storm Grate/Utility Type	
		N/A			N/A
N/A	Surface Condition	Good

Remove & Replace Entire Refuge.
