Access Compliance Report

Public Rights-of-Way

(Island Curb Cuts)

Intersection ID: 10036062	Main Street: RIVERGATE_PY	Cross Street: N/A	Location: SE
ADA ID: E0C65F8B9ACC	Curb Cut Type: MedianRefuge2	Initial Pass/Fail: Fail	Overall Compliance: No
Severity Score: 8.75			
Codes/Mitigation Info/Possible Solution		Field Measurements/Component Compliance

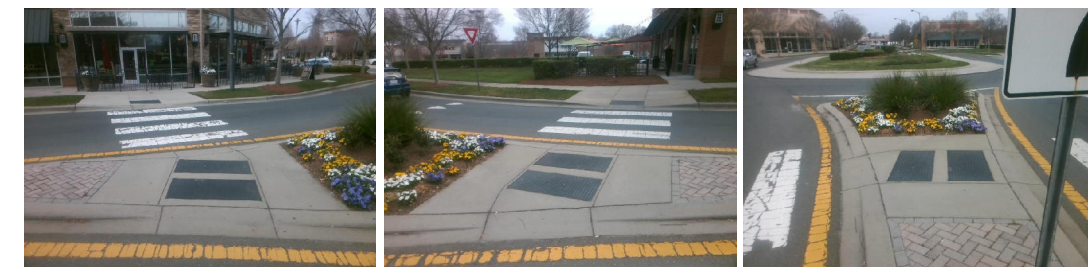
Compliance	Description	Data	Compliance	Description	Data
No	Refuge 1 Length (In)	35.5	N/A	Gutter 1 Ponding?	N/A
No	Refuge 1 Width (In)	51.0	N/A	Gutter 1 Lip Ht (In)	N/A
Yes	Refuge 1 Slope (%)	1.6	N/A	Gutter 1 Slope (%)	N/A
Yes	Refuge 1 X Slope (%)	2.2	N/A	Gutter 1 X Slope (%)	N/A
N/A	Painted X Walk1?	Yes	N/A	DWS 1 Provided?	N/A
N/A	X Walk 1 Direction	To SW	N/A	DWS 1 Contrast?	N/A
N/A	X Walk 1 Width (In)	121.0	N/A	DWS 1 Length (In)	N/A
N/A	Road 1 Slope (%)	2.6	N/A	DWS 1 Full Width?	N/A
N/A	Road 1 X Slope (%)	0.9	N/A	DWS 1 Offset (In)	N/A
No	Refuge 2 Length (In)	35.5	N/A	Gutter 2 Ponding?	N/A
No	Refuge 2 Width (In)	51.0	N/A	Gutter 2 Lip Ht (In)	N/A
Yes	Refuge 2 Slope (%)	1.6	N/A	Gutter 2 Slope (%)	N/A
Yes	Refuge 2 X Slope (%)	1.4	N/A	Gutter 2 X Slope (%)	N/A
N/A	Painted X Walk2?	Yes	N/A	DWS 2 Provided?	N/A
N/A	X Walk 2 Direction	To NE	N/A	DWS 2 Contrast?	N/A
N/A	X Walk 2 Width (In)	120.0	N/A	DWS 2 Length (In)	N/A

N/A	Road 2 Slope (%)	2.9	N/A	DWS 2 Full Width?	N/A
N/A	Road 2 X Slope (%)	1.6	N/A	DWS 2 Offset (In)	N/A
N/A	Refuge 3 Length (in)	N/A	N/A	Gutter 3 Ponding?	N/A
N/A	Refuge 3 Width (in)	N/A	N/A	Gutter 3 Lip Ht (in)	N/A
N/A	Refuge 3 Slope (%)	N/A	N/A	Gutter 3 Slope (%)	N/A
N/A	Refuge 3 XSlope (%)	N/A	N/A	Gutter 3 XSlope (%)	N/A
N/A	Painted X Walk3?	N/A	N/A	DWS 3 Provided?	N/A
N/A	X Walk 3 Direction	N/A	N/A	DWS 3 Contrast?	N/A
N/A	X Walk 3 Width (in)	N/A	N/A	DWS 3 Length (in)	N/A
N/A	Road 3 Slope (%)	N/A	N/A	DWS 3 Full Width?	N/A
N/A	Road 3 XSlope (%)	N/A	N/A	DWS 3 Offset (in)	N/A
Yes	Any Obstructions?	N/A	N/A	Storm Grate/Utility Hazard?	N/A
N/A	Obstruction Type		N/A	Storm Grate/Utility Type	
		N/A			N/A
N/A	Surface Condition	Good

Possible Solutions:

Remove & Replace Entire Refuge.
