# Access Compliance Report

## Public Rights-of-Way

### (Island Curb Cuts)

| Intersection ID: 28291 | Main Street: COMMUNITY HOUSE RD | Cross Street: ARDREY KELL RD | Location: SE |

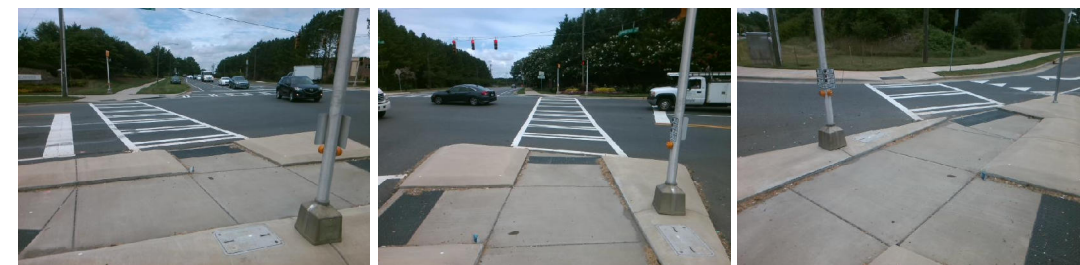
| Compliance | Description | Data | Compliance | Description | Data |
|---|---|---|---|---|---|
| N/A | Road 1 X Slope (%) | 1.2 | No | DWS 1 Offset (In) | 6.0 |

**Remove & Replace Detectable Warning System.**
