Access Compliance Report

Public Rights-of-Way

(Island Curb Cuts)

Intersection ID: 52893	Main Street: TWITTER_LN	Cross Street: SANCTUARY_PL	Location:	N
ADA ID: E564C24D1759	Curb Cut Type: MedianRefuge2	Initial Pass/Fail: Fail	Overall Compliance: No	Severity Score: 8.75
Codes/Mitigation Info/Possible Solution		Field Measurements/Component Compliance

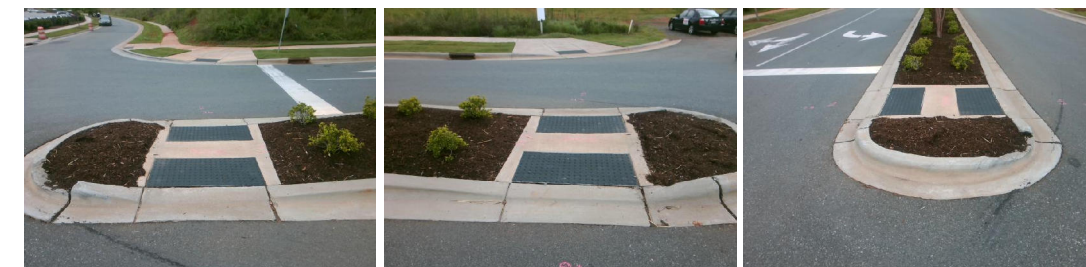
Compliance	Description	Data	Compliance	Description	Data
No	Refuge 1 Length (In)	35.5	N/A	Gutter 1 Ponding?	N/A
No	Refuge 1 Width (In)	48.0	N/A	Gutter 1 Lip Ht (In)	N/A
Yes	Refuge 1 Slope (%)	1.2	N/A	Gutter 1 Slope (%)	N/A
Yes	Refuge 1 X Slope (%)	4.0	N/A	Gutter 1 X Slope (%)	N/A
N/A	Painted X Walk1?	No	N/A	DWS 1 Provided?	N/A
N/A	X Walk 1 Direction	To W	N/A	DWS 1 Contrast?	N/A
N/A	X Walk 1 Width (In)	N/A	N/A	DWS 1 Length (In)	N/A
N/A	Road 1 Slope (%)	4.6	N/A	DWS 1 Full Width?	N/A
N/A	Road 1 X Slope (%)	2.3	N/A	DWS 1 Offset (In)	N/A
No	Refuge 2 Length (In)	35.5	N/A	Gutter 2 Ponding?	N/A
No	Refuge 2 Width (In)	48.0	N/A	Gutter 2 Lip Ht (In)	N/A
Yes	Refuge 2 Slope (%)	0.0	N/A	Gutter 2 Slope (%)	N/A
Yes	Refuge 2 X Slope (%)	2.6	N/A	Gutter 2 X Slope (%)	N/A
N/A	Painted X Walk2?	No	N/A	DWS 2 Provided?	N/A
N/A	X Walk 2 Direction	To E	N/A	DWS 2 Contrast?	N/A
N/A	X Walk 2 Width (In)	N/A	N/A	DWS 2 Length (In)	N/A
N/A	Road 2 Slope (%)	4.3	N/A	DWS 2 Full Width?	N/A

N/A	Road 2 X Slope (%)	3.3	N/A	DWS 2 Offset (In)	N/A
N/A	Refuge 3 Length (in)	N/A	N/A	Gutter 3 Ponding?	N/A
N/A	Refuge 3 Width (in)	N/A	N/A	Gutter 3 Lip Ht (in)	N/A
N/A	Refuge 3 Slope (%)	N/A	N/A	Gutter 3 Slope (%)	N/A
N/A	Refuge 3 XSlope (%)	N/A	N/A	Gutter 3 XSlope (%)	N/A
N/A	Painted X Walk3?	No	N/A	DWS 3 Provided?	N/A
N/A	X Walk 3 Direction	N/A	N/A	DWS 3 Contrast?	N/A
N/A	X Walk 3 Width (in)	N/A	N/A	DWS 3 Length (in)	N/A
N/A	Road 3 Slope (%)	N/A	N/A	DWS 3 Full Width?	N/A
N/A	Road 3 XSlope (%)	N/A	N/A	DWS 3 Offset (in)	N/A
Yes	Any Obstructions?	N/A	N/A	Storm Grate/Utility Hazard?	N/A
N/A	Obstruction Type		N/A	Storm Grate/Utility Type	
		N/A			N/A
N/A	Surface Condition	Good

Remove & Replace Entire Refuge.
