Access Compliance Report

Public Rights-of-Way

(Island Curb Cuts)

Intersection ID: 10032879	Main Street: NATIONS_FORD_RD	Cross Street: N/A	Location: N
ADA ID: E7F3B4FDCABB	Curb Cut Type: MedianRefuge2	Initial Pass/Fail: Pass	Overall Compliance: Yes
Codes/Mitigation Info/Possible Solution		Field Measurements/Component Compliance	
Severity Score: 0.25

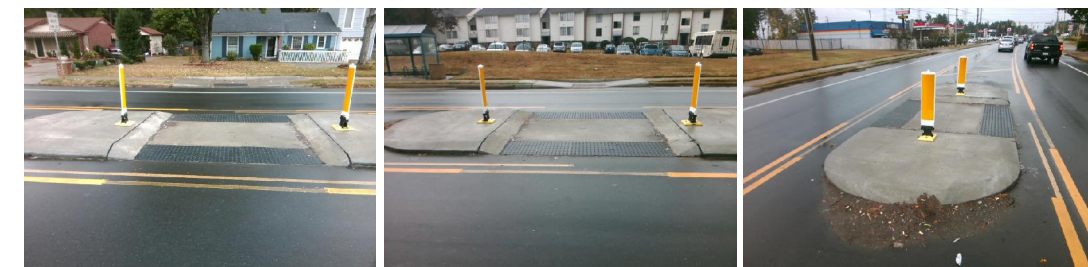
Compliance	Description	Data	Compliance	Description	Data
Yes	Refuge 1 Length (In)	54.0	Yes	Gutter 1 Ponding?	No
Yes	Refuge 1 Width (In)	100.0	Yes	Gutter 1 Lip Ht (In)	0.0
Yes	Refuge 1 Slope (%)	3.2	Yes	Gutter 1 Slope (%)	0.2
Yes	Refuge 1 X Slope (%)	1.1	Yes	Gutter 1 X Slope (%)	0.4
N/A	Painted X Walk1?	No	Yes	DWS 1 Provided?	Yes
N/A	X Walk 1 Direction	To E	Yes	DWS 1 Contrast?	Yes
N/A	X Walk 1 Width (In)	N/A	Yes	DWS 1 Length (In)	24.0
N/A	Road 1 Slope (%)	0.7	Yes	DWS 1 Full Width?	Yes
N/A	Road 1 X Slope (%)	0.6	Yes	DWS 1 Offset (In)	0.0
Yes	Refuge 2 Length (In)	54.0	Yes	Gutter 2 Ponding?	No
Yes	Refuge 2 Width (In)	100.0	Yes	Gutter 2 Lip Ht (In)	0.0
Yes	Refuge 2 Slope (%)	1.8	Yes	Gutter 2 Slope (%)	4.6
Yes	Refuge 2 X Slope (%)	0.5	Yes	Gutter 2 X Slope (%)	0.8
N/A	Painted X Walk2?	No	Yes	DWS 2 Provided?	Yes
N/A	X Walk 2 Direction	To W	Yes	DWS 2 Contrast?	Yes
N/A	X Walk 2 Width (In)	N/A	Yes	DWS 2 Length (In)	24.0

N/A	Road 2 Slope (%)	0.7	Yes	DWS 2 Full Width?	Yes
N/A	Road 2 X Slope (%)	4.6	Yes	DWS 2 Offset (In)	0.0
N/A	Refuge 3 Length (in)	N/A	N/A	Gutter 3 Ponding?	N/A
N/A	Refuge 3 Width (in)	N/A	N/A	Gutter 3 Lip Ht (in)	N/A
N/A	Refuge 3 Slope (%)	N/A	N/A	Gutter 3 Slope (%)	N/A
N/A	Refuge 3 XSlope (%)	N/A	N/A	Gutter 3 XSlope (%)	N/A
N/A	Painted X Walk3?	N/A	N/A	DWS 3 Provided?	N/A
N/A	X Walk 3 Direction	N/A	N/A	DWS 3 Contrast?	N/A
N/A	X Walk 3 Width (in)	N/A	N/A	DWS 3 Length (in)	N/A
N/A	Road 3 Slope (%)	N/A	N/A	DWS 3 Full Width?	N/A
N/A	Road 3 XSlope (%)	N/A	N/A	DWS 3 Offset (in)	N/A
Yes	Any Obstructions?	N/A	N/A	Storm Grate/Utility Hazard?	No
N/A	Obstruction Type		N/A	Storm Grate/Utility Type	
		N/A			N/A
N/A	Surface Condition	Good

Possible Solutions:

N/A
