Access Compliance Report

Public Rights-of-Way

(Island Curb Cuts)

Intersection ID: 53294	Main Street: JOHNSTON_OEHLER_RD	Cross Street: N/A	Location: W
ADA ID: E8F7D4078985	Curb Cut Type: MedianRefuge2	Initial Pass/Fail: Fail	Overall Compliance: No
Codes/Mitigation Info/Possible Solution		Field Measurements/Component Compliance

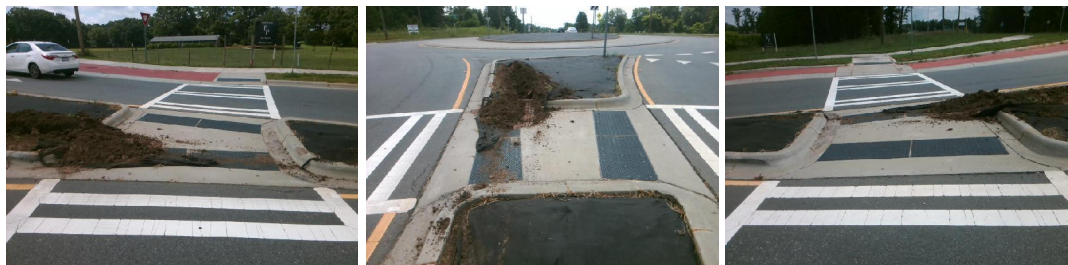
Compliance	Description	Data	Compliance	Description	Data
Yes	Refuge 1 Length (In)	46.0	N/A	Gutter 1 Ponding?	N/A
Yes	Refuge 1 Width (In)	117.0	N/A	Gutter 1 Lip Ht (In)	N/A
Yes	Refuge 1 Slope (%)	0.1	N/A	Gutter 1 Slope (%)	N/A
No	Refuge 1 X Slope (%)	5.4	N/A	Gutter 1 X Slope (%)	N/A
N/A	Painted X Walk1?	Yes	N/A	DWS 1 Provided?	N/A
N/A	X Walk 1 Direction	To N	N/A	DWS 1 Contrast?	N/A
N/A	X Walk 1 Width (In)	112.0	N/A	DWS 1 Length (In)	N/A
N/A	Road 1 Slope (%)	3.5	N/A	DWS 1 Full Width?	N/A
N/A	Road 1 X Slope (%)	1.0	N/A	DWS 1 Offset (In)	N/A
Yes	Refuge 2 Length (In)	43.0	N/A	Gutter 2 Ponding?	N/A
Yes	Refuge 2 Width (In)	117.0	N/A	Gutter 2 Lip Ht (In)	N/A
Yes	Refuge 2 Slope (%)	2.2	N/A	Gutter 2 Slope (%)	N/A
No	Refuge 2 X Slope (%)	5.2	N/A	Gutter 2 X Slope (%)	N/A
N/A	Painted X Walk2?	Yes	N/A	DWS 2 Provided?	N/A
N/A	X Walk 2 Direction	To S	N/A	DWS 2 Contrast?	N/A
N/A	X Walk 2 Width (In)	112.0	N/A	DWS 2 Length (In)	N/A

N/A	Road 2 Slope (%)	4.3	N/A	DWS 2 Full Width?	N/A
N/A	Road 2 X Slope (%)	1.2	N/A	DWS 2 Offset (In)	N/A
N/A	Refuge 3 Length (in)	N/A	N/A	Gutter 3 Ponding?	N/A
N/A	Refuge 3 Width (in)	N/A	N/A	Gutter 3 Lip Ht (in)	N/A
N/A	Refuge 3 Slope (%)	N/A	N/A	Gutter 3 Slope (%)	N/A
N/A	Refuge 3 XSlope (%)	N/A	N/A	Gutter 3 XSlope (%)	N/A
N/A	Painted X Walk3?	No	N/A	DWS 3 Provided?	N/A
N/A	X Walk 3 Direction	N/A	N/A	DWS 3 Contrast?	N/A
N/A	X Walk 3 Width (in)	N/A	N/A	DWS 3 Length (in)	N/A
N/A	Road 3 Slope (%)	N/A	N/A	DWS 3 Full Width?	N/A
N/A	Road 3 XSlope (%)	N/A	N/A	DWS 3 Offset (in)	N/A
Yes	Any Obstructions?	N/A	N/A	Storm Grate/Utility Hazard?	N/A
N/A	Obstruction Type		N/A	Storm Grate/Utility Type	
		N/A			N/A
N/A	Surface Condition	Good

Remove & Replace Entire Refuge.
