Access Compliance Report

Public Rights-of-Way

(Island Curb Cuts)

Intersection ID: 10012508	Main Street: MILTON_RD	Cross Street: N/A	Location: S
ADA ID: EAB03269A7DA	Curb Cut Type: MedianRefuge2	Initial Pass/Fail: Fail	Overall Compliance: No
		Severity Score: 1.25

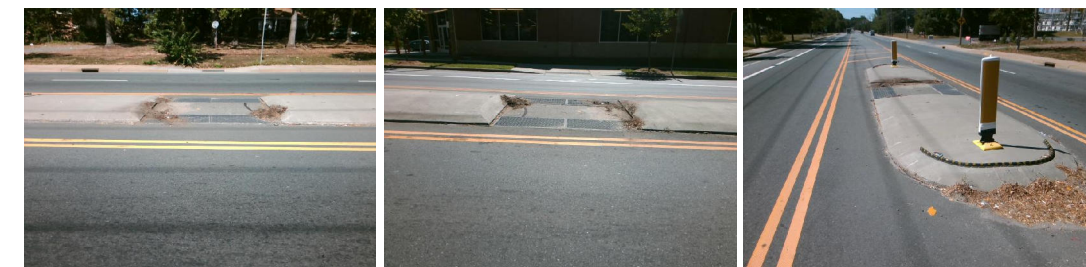
Compliance	Description	Data	Compliance	Description	Data
Yes	Refuge 1 Length (In)	48.0	N/A	Gutter 1 Ponding?	N/A
Yes	Refuge 1 Width (In)	99.0	N/A	Gutter 1 Lip Ht (In)	N/A
Yes	Refuge 1 Slope (%)	1.0	N/A	Gutter 1 Slope (%)	N/A
Yes	Refuge 1 X Slope (%)	2.0	N/A	Gutter 1 X Slope (%)	N/A
N/A	Painted X Walk1?	No	N/A	DWS 1 Provided?	N/A
N/A	X Walk 1 Direction	To S	N/A	DWS 1 Contrast?	N/A
N/A	X Walk 1 Width (In)	N/A	N/A	DWS 1 Length (In)	N/A
N/A	Road 1 Slope (%)	1.9	N/A	DWS 1 Full Width?	N/A
N/A	Road 1 X Slope (%)	1.8	N/A	DWS 1 Offset (In)	N/A
Yes	Refuge 2 Length (In)	48.0	N/A	Gutter 2 Ponding?	N/A
Yes	Refuge 2 Width (In)	99.0	N/A	Gutter 2 Lip Ht (In)	N/A
Yes	Refuge 2 Slope (%)	3.3	N/A	Gutter 2 Slope (%)	N/A
Yes	Refuge 2 X Slope (%)	2.2	N/A	Gutter 2 X Slope (%)	N/A
N/A	Painted X Walk2?	No	N/A	DWS 2 Provided?	N/A
N/A	X Walk 2 Direction	To N	N/A	DWS 2 Contrast?	N/A
N/A	X Walk 2 Width (In)	N/A	N/A	DWS 2 Length (In)	N/A

N/A	Road 2 Slope (%)	1.9	N/A	DWS 2 Full Width?	N/A
N/A	Road 2 X Slope (%)	2.1	N/A	DWS 2 Offset (In)	N/A
N/A	Refuge 3 Length (in)	N/A	N/A	Gutter 3 Ponding?	N/A
N/A	Refuge 3 Width (in)	N/A	N/A	Gutter 3 Lip Ht (in)	N/A
N/A	Refuge 3 Slope (%)	N/A	N/A	Gutter 3 Slope (%)	N/A
N/A	Refuge 3 XSlope (%)	N/A	N/A	Gutter 3 XSlope (%)	N/A
N/A	Painted X Walk3?	N/A	N/A	DWS 3 Provided?	N/A
N/A	X Walk 3 Direction	N/A	N/A	DWS 3 Contrast?	N/A
N/A	X Walk 3 Width (in)	N/A	N/A	DWS 3 Length (in)	N/A
N/A	Road 3 Slope (%)	N/A	N/A	DWS 3 Full Width?	N/A
N/A	Road 3 XSlope (%)	N/A	N/A	DWS 3 Offset (in)	N/A
Yes	Any Obstructions?	N/A	N/A	Storm Grate/Utility Hazard?	N/A
N/A	Obstruction Type		N/A	Storm Grate/Utility Type	
		N/A			N/A
N/A	Surface Condition	Good

Remove & Replace Entire Refuge.
