# Access Compliance Report

## Public Rights-of-Way

### (Island Curb Cuts)

Intersection ID: 5421	Main Street: SUNSET_RD	Cross Street: OLD_STATESVILLE_RD	Location: NW
ADA ID: EBA6FA470831	Curb Cut Type: IslandRefuge3	Initial Pass/Fail: Fail	Overall Compliance: No
Severity Score: 60			
Codes/Mitigation Info/Possible Solution		Field Measurements/Component Compliance

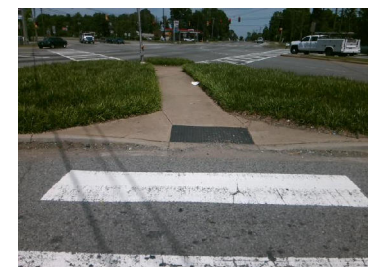
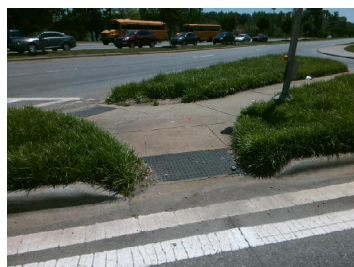
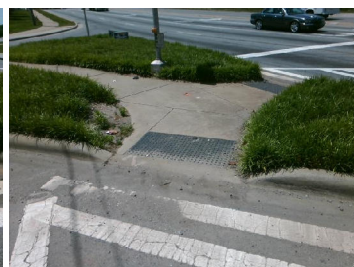
Compliance	Description	Data	Compliance	Description	Data
Yes	Refuge 1 Length (In)	63.0	N/A	Gutter 1 Ponding?	N/A
No	Refuge 1 Width (In)	53.0	N/A	Gutter 1 Lip Ht (In)	N/A
No	Refuge 1 Slope (%)	6.5	N/A	Gutter 1 Slope (%)	N/A
Yes	Refuge 1 X Slope (%)	0.6	N/A	Gutter 1 X Slope (%)	N/A
N/A	Painted X Walk1?	Yes	N/A	DWS 1 Provided?	N/A
N/A	X Walk 1 Direction	To NW	N/A	DWS 1 Contrast?	N/A
N/A	X Walk 1 Width (In)	135.0	N/A	DWS 1 Length (In)	N/A
N/A	Road 1 Slope (%)	0.6	N/A	DWS 1 Full Width?	N/A
N/A	Road 1 X Slope (%)	2.2	N/A	DWS 1 Offset (In)	N/A
Yes	Refuge 2 Length (In)	60.0	N/A	Gutter 2 Ponding?	N/A
Yes	Refuge 2 Width (In)	64.0	N/A	Gutter 2 Lip Ht (In)	N/A
Yes	Refuge 2 Slope (%)	0.7	N/A	Gutter 2 Slope (%)	N/A
Yes	Refuge 2 X Slope (%)	0.9	N/A	Gutter 2 X Slope (%)	N/A
N/A	Painted X Walk2?	Yes	N/A	DWS 2 Provided?	N/A
N/A	X Walk 2 Direction	To NE	N/A	DWS 2 Contrast?	N/A
N/A	X Walk 2 Width (In)	135.0	N/A	DWS 2 Length (In)	N/A

N/A	Road 2 Slope (%)	0.0	N/A	DWS 2 Full Width?	N/A
N/A	Road 2 X Slope (%)	0.1	N/A	DWS 2 Offset (In)	N/A
Yes	Refuge 3 Length (in)	384	N/A	Gutter 3 Ponding?	N/A
No	Refuge 3 Width (in)	51.0	N/A	Gutter 3 Lip Ht (in)	N/A
No	Refuge 3 Slope (%)	10.0	N/A	Gutter 3 Slope (%)	N/A
Yes	Refuge 3 XSlope (%)	0.1	N/A	Gutter 3 XSlope (%)	N/A
N/A	Painted X Walk3?	Yes	N/A	DWS 3 Provided?	N/A
N/A	X Walk 3 Direction	To S	N/A	DWS 3 Contrast?	N/A
N/A	X Walk 3 Width (in)	120.0	N/A	DWS 3 Length (in)	N/A
N/A	Road 3 Slope (%)	0.7	N/A	DWS 3 Full Width?	N/A
N/A	Road 3 XSlope (%)	2.2	N/A	DWS 3 Offset (in)	N/A
Yes	Any Obstructions?	N/A	N/A	Storm Grate/Utility Hazard?	N/A
N/A	Obstruction Type		N/A	Storm Grate/Utility Type	
N/A	Surface Condition	Good	N/A		N/A

**Remove & Replace Entire Refuge.**
