# Access Compliance Report

## Public Rights-of-Way

### (Island Curb Cuts)

Intersection ID: 10035076	Main Street: PROVIDENCE_RD	Cross Street: HEATHERWOODS APARTMENT DR	Location: E
ADA ID: EC7F3BE9DC8B	Curb Cut Type: MedianRefuge2	Initial Pass/Fail: Fail	Overall Compliance: No
		Severity Score: 21.25

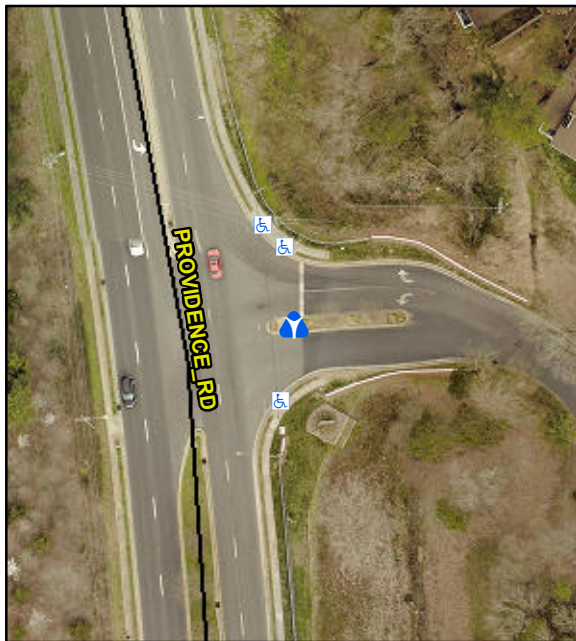
Compliance	Description	Data	Compliance	Description	Data
Yes	Refuge 1 Length (In)	44.5	N/A	Gutter 1 Ponding?	N/A
No	Refuge 1 Width (In)	48.0	N/A	Gutter 1 Lip Ht (In)	N/A
Yes	Refuge 1 Slope (%)	0.1	N/A	Gutter 1 Slope (%)	N/A
No	Refuge 1 X Slope (%)	7.8	N/A	Gutter 1 X Slope (%)	N/A
N/A	Painted X Walk1?	No	N/A	DWS 1 Provided?	N/A
N/A	X Walk 1 Direction	To N	N/A	DWS 1 Contrast?	N/A
N/A	X Walk 1 Width (In)	N/A	N/A	DWS 1 Length (In)	N/A
N/A	Road 1 Slope (%)	8.2	N/A	DWS 1 Full Width?	N/A
N/A	Road 1 X Slope (%)	3.1	N/A	DWS 1 Offset (In)	N/A
Yes	Refuge 2 Length (In)	44.5	N/A	Gutter 2 Ponding?	N/A
No	Refuge 2 Width (In)	48.0	N/A	Gutter 2 Lip Ht (In)	N/A
Yes	Refuge 2 Slope (%)	1.2	N/A	Gutter 2 Slope (%)	N/A
No	Refuge 2 X Slope (%)	9.9	N/A	Gutter 2 X Slope (%)	N/A
N/A	Painted X Walk2?	No	N/A	DWS 2 Provided?	N/A
N/A	X Walk 2 Direction	To S	N/A	DWS 2 Contrast?	N/A
N/A	X Walk 2 Width (In)	N/A	N/A	DWS 2 Length (In)	N/A
N/A	Road 2 Slope (%)	9.1	N/A	DWS 2 Full Width?	N/A

N/A	Road 2 X Slope (%)	0.1	N/A	DWS 2 Offset (In)	N/A
N/A	Refuge 3 Length (in)	N/A	N/A	Gutter 3 Ponding?	N/A
N/A	Refuge 3 Width (in)	N/A	N/A	Gutter 3 Lip Ht (in)	N/A
N/A	Refuge 3 Slope (%)	N/A	N/A	Gutter 3 Slope (%)	N/A
N/A	Refuge 3 XSlope (%)	N/A	N/A	Gutter 3 XSlope (%)	N/A
N/A	Painted X Walk3?	N/A	N/A	DWS 3 Provided?	N/A
N/A	X Walk 3 Direction	N/A	N/A	DWS 3 Contrast?	N/A
N/A	X Walk 3 Width (in)	N/A	N/A	DWS 3 Length (in)	N/A
N/A	Road 3 Slope (%)	N/A	N/A	DWS 3 Full Width?	N/A
N/A	Road 3 XSlope (%)	N/A	N/A	DWS 3 Offset (in)	N/A
Yes	Any Obstructions?	N/A	N/A	Storm Grate/Utility Hazard?	N/A
N/A	Obstruction Type		N/A	Storm Grate/Utility Type	
			N/A		N/A
N/A	Surface Condition	Good

**Remove & Replace Entire Refuge.**

**\$ 3000.00**
