Access Compliance Report

Public Rights-of-Way

(Island Curb Cuts)

Intersection ID: 10035583	Main Street: REAMES_RD	Cross Street: N/A	Location: N
ADA ID: ED6C7E6410D1	Curb Cut Type: MedianRefuge2	Initial Pass/Fail: Pass	Overall Compliance: No
Codes/Mitigation Info/Possible Solution		Field Measurements/Component Compliance

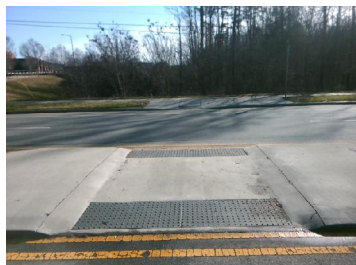
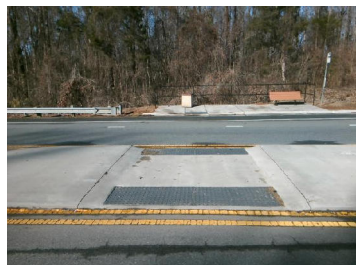
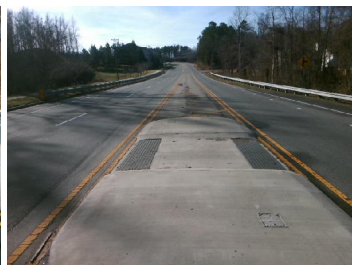
Compliance	Description	Data	Compliance	Description	Data
Yes	Refuge 1 Length (In)	65.5	Yes	Gutter 1 Ponding?	No
Yes	Refuge 1 Width (In)	96.0	Yes	Gutter 1 Lip Ht (In)	0.0
Yes	Refuge 1 Slope (%)	2.1	Yes	Gutter 1 Slope (%)	0.6
Yes	Refuge 1 X Slope (%)	1.0	Yes	Gutter 1 X Slope (%)	1.0
N/A	Painted X Walk1?	No	Yes	DWS 1 Provided?	Yes
N/A	X Walk 1 Direction	To SE	Yes	DWS 1 Contrast?	Yes
N/A	X Walk 1 Width (In)	N/A	Yes	DWS 1 Length (In)	24.0
N/A	Road 1 Slope (%)	0.6	Yes	DWS 1 Full Width?	Yes
N/A	Road 1 X Slope (%)	2.4	No	DWS 1 Offset (In)	4.0
Yes	Refuge 2 Length (In)	65.5	Yes	Gutter 2 Ponding?	No
Yes	Refuge 2 Width (In)	96.0	Yes	Gutter 2 Lip Ht (In)	0.0
Yes	Refuge 2 Slope (%)	2.7	Yes	Gutter 2 Slope (%)	2.3
Yes	Refuge 2 X Slope (%)	0.8	Yes	Gutter 2 X Slope (%)	0.1
N/A	Painted X Walk2?	No	Yes	DWS 2 Provided?	Yes
N/A	X Walk 2 Direction	To NW	Yes	DWS 2 Contrast?	Yes
N/A	X Walk 2 Width (In)	N/A	Yes	DWS 2 Length (In)	24.0

N/A	Road 2 Slope (%)	0.5	Yes	DWS 2 Full Width?	Yes
N/A	Road 2 X Slope (%)	2.6	No	DWS 2 Offset (In)	4.0
N/A	Refuge 3 Length (in)	N/A	N/A	Gutter 3 Ponding?	N/A
N/A	Refuge 3 Width (in)	N/A	N/A	Gutter 3 Lip Ht (in)	N/A
N/A	Refuge 3 Slope (%)	N/A	N/A	Gutter 3 Slope (%)	N/A
N/A	Refuge 3 XSlope (%)	N/A	N/A	Gutter 3 XSlope (%)	N/A
N/A	Painted X Walk3?	N/A	N/A	DWS 3 Provided?	N/A
N/A	X Walk 3 Direction	N/A	N/A	DWS 3 Contrast?	N/A
N/A	X Walk 3 Width (in)	N/A	N/A	DWS 3 Length (in)	N/A
N/A	Road 3 Slope (%)	N/A	N/A	DWS 3 Full Width?	N/A
N/A	Road 3 XSlope (%)	N/A	N/A	DWS 3 Offset (in)	N/A
Yes	Any Obstructions?	No	N/A	Storm Grate/Utility Hazard?	No
N/A	Obstruction Type		N/A	Storm Grate/Utility Type	
		N/A			N/A
N/A	Surface Condition	Good

Possible Solutions:

Remove & Replace Detectable Warning System.
