Access Compliance Report

Public Rights-of-Way

(Island Curb Cuts)

Intersection ID: 51572	Main Street: FREEDOM_DR	Cross Street: WESLEY_VILLAGE_RD	Location: S
ADA ID: EDD852990838	Curb Cut Type: MedianRefuge2	Initial Pass/Fail: Fail	Overall Compliance: No
Codes/Mitigation Info/Possible Solution		Field Measurements/Component Compliance

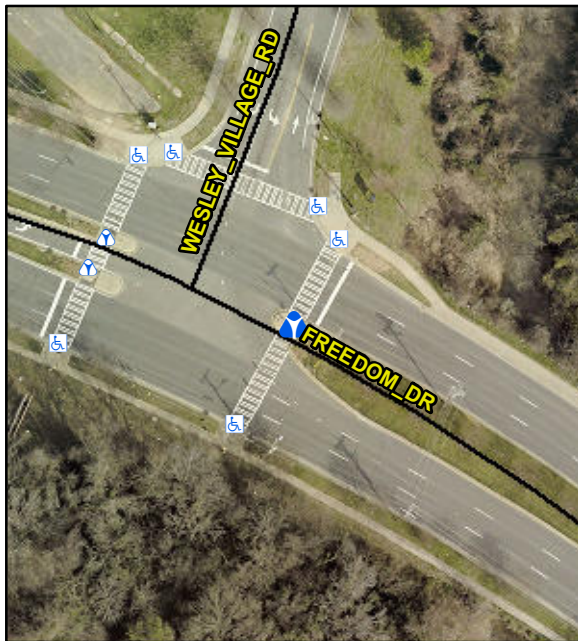
Compliance	Description	Data	Compliance	Description	Data
Yes	Refuge 1 Length (In)	64.0	N/A	Gutter 1 Ponding?	N/A
Yes	Refuge 1 Width (In)	96.0	N/A	Gutter 1 Lip Ht (In)	N/A
Yes	Refuge 1 Slope (%)	4.5	N/A	Gutter 1 Slope (%)	N/A
Yes	Refuge 1 X Slope (%)	2.7	N/A	Gutter 1 X Slope (%)	N/A
N/A	Painted X Walk1?	Yes	N/A	DWS 1 Provided?	N/A
N/A	X Walk 1 Direction	To S	N/A	DWS 1 Contrast?	N/A
N/A	X Walk 1 Width (In)	104.0	N/A	DWS 1 Length (In)	N/A
N/A	Road 1 Slope (%)	0.5	N/A	DWS 1 Full Width?	N/A
N/A	Road 1 X Slope (%)	3.0	N/A	DWS 1 Offset (In)	N/A
Yes	Refuge 2 Length (In)	64.0	N/A	Gutter 2 Ponding?	N/A
Yes	Refuge 2 Width (In)	96.0	N/A	Gutter 2 Lip Ht (In)	N/A
Yes	Refuge 2 Slope (%)	0.6	N/A	Gutter 2 Slope (%)	N/A
Yes	Refuge 2 X Slope (%)	2.0	N/A	Gutter 2 X Slope (%)	N/A
N/A	Painted X Walk2?	Yes	N/A	DWS 2 Provided?	N/A
N/A	X Walk 2 Direction	To N	N/A	DWS 2 Contrast?	N/A
N/A	X Walk 2 Width (In)	104.0	N/A	DWS 2 Length (In)	N/A

N/A	Road 2 Slope (%)	1.7	N/A	DWS 2 Full Width?	N/A
N/A	Road 2 X Slope (%)	7.6	N/A	DWS 2 Offset (In)	N/A
N/A	Refuge 3 Length (in)	N/A	N/A	Gutter 3 Ponding?	N/A
N/A	Refuge 3 Width (in)	N/A	N/A	Gutter 3 Lip Ht (in)	N/A
N/A	Refuge 3 Slope (%)	N/A	N/A	Gutter 3 Slope (%)	N/A
N/A	Refuge 3 XSlope (%)	N/A	N/A	Gutter 3 XSlope (%)	N/A
N/A	Painted X Walk3?	N/A	N/A	DWS 3 Provided?	N/A
N/A	X Walk 3 Direction	N/A	N/A	DWS 3 Contrast?	N/A
N/A	X Walk 3 Width (in)	N/A	N/A	DWS 3 Length (in)	N/A
N/A	Road 3 Slope (%)	N/A	N/A	DWS 3 Full Width?	N/A
N/A	Road 3 XSlope (%)	N/A	N/A	DWS 3 Offset (in)	N/A
Yes	Any Obstructions?	N/A	N/A	Storm Grate/Utility Hazard?	N/A
N/A	Obstruction Type		N/A	Storm Grate/Utility Type	
		N/A			N/A
N/A	Surface Condition	Good

Remove & Replace Entire Refuge.
