Access Compliance Report

Public Rights-of-Way

(Island Curb Cuts)

Intersection ID: 52582	Main Street: NOBLES_AV	Cross Street: BURNETTE_AV	Location: NE
ADA ID: EE4670AA62C0	Curb Cut Type: MedianRefuge2	Initial Pass/Fail: Fail	Overall Compliance: No
Severity Score: 12.5			
Codes/Mitigation Info/Possible Solution		Field Measurements/Component Compliance

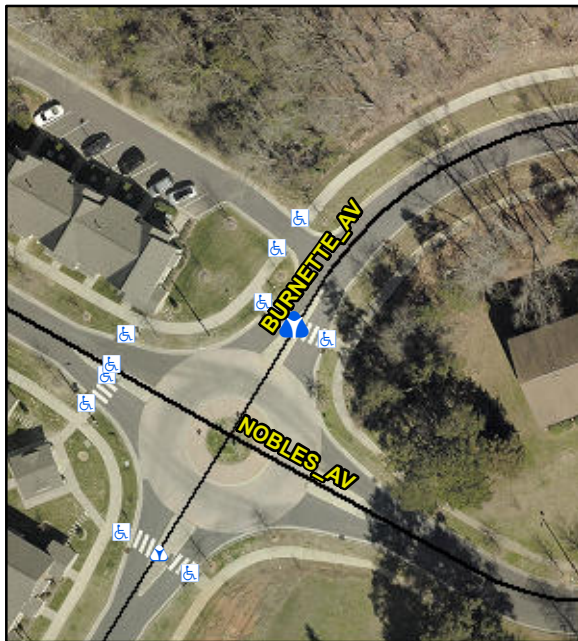
Compliance	Description	Data	Compliance	Description	Data
Yes	Refuge 1 Length (In)	41.0	N/A	Gutter 1 Ponding?	N/A
Yes	Refuge 1 Width (In)	71.0	N/A	Gutter 1 Lip Ht (In)	N/A
No	Refuge 1 Slope (%)	5.1	N/A	Gutter 1 Slope (%)	N/A
Yes	Refuge 1 X Slope (%)	2.7	N/A	Gutter 1 X Slope (%)	N/A
N/A	Painted X Walk1?	Yes	N/A	DWS 1 Provided?	N/A
N/A	X Walk 1 Direction	To NW	N/A	DWS 1 Contrast?	N/A
N/A	X Walk 1 Width (In)	120.0	N/A	DWS 1 Length (In)	N/A
N/A	Road 1 Slope (%)	1.4	N/A	DWS 1 Full Width?	N/A
N/A	Road 1 X Slope (%)	1.6	N/A	DWS 1 Offset (In)	N/A
Yes	Refuge 2 Length (In)	41.0	N/A	Gutter 2 Ponding?	N/A
Yes	Refuge 2 Width (In)	71.0	N/A	Gutter 2 Lip Ht (In)	N/A
Yes	Refuge 2 Slope (%)	4.7	N/A	Gutter 2 Slope (%)	N/A
Yes	Refuge 2 X Slope (%)	0.6	N/A	Gutter 2 X Slope (%)	N/A
N/A	Painted X Walk2?	Yes	N/A	DWS 2 Provided?	N/A
N/A	X Walk 2 Direction	To SE	N/A	DWS 2 Contrast?	N/A
N/A	X Walk 2 Width (In)	120.0	N/A	DWS 2 Length (In)	N/A

Possible Solutions:

Remove & Replace Entire Refuge.
