Access Compliance Report

Public Rights-of-Way

(Island Curb Cuts)

Intersection ID: 6370	Main Street: LAKE_RD	Cross Street: MILHAVEN_LN	Location:	N
ADA ID: EE87D1BF8A9E	Curb Cut Type: MedianRefuge2	Initial Pass/Fail: Pass	Overall Compliance: No	Severity Score: 0
Codes/Mitigation Info/Possible Solution		Field Measurements/Component Compliance

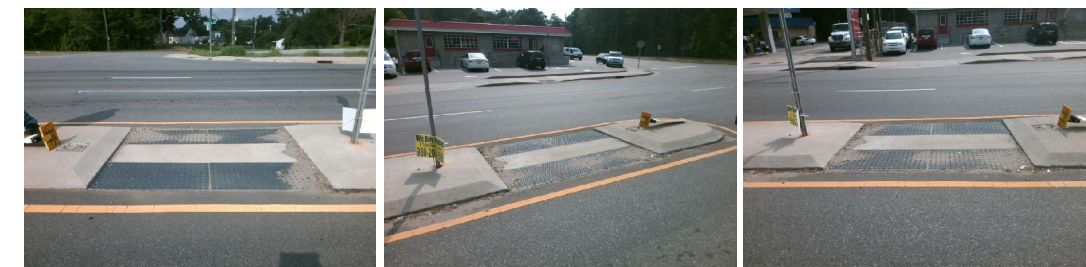
Compliance	Description	Data	Compliance	Description	Data
Yes	Refuge 1 Length (In)	36.0	No	Gutter 1 Ponding?	Yes
Yes	Refuge 1 Width (In)	96.0	No	Gutter 1 Lip Ht (In)	0.25
Yes	Refuge 1 Slope (%)	0.7	Yes	Gutter 1 Slope (%)	3.3
Yes	Refuge 1 X Slope (%)	0.9	Yes	Gutter 1 X Slope (%)	0.2
N/A	Painted X Walk1?	No	Yes	DWS 1 Provided?	Yes
N/A	X Walk 1 Direction	To E	Yes	DWS 1 Contrast?	Yes
N/A	X Walk 1 Width (In)	N/A	Yes	DWS 1 Length (In)	24.0
N/A	Road 1 Slope (%)	0.5	Yes	DWS 1 Full Width?	Yes
N/A	Road 1 X Slope (%)	4.9	Yes	DWS 1 Offset (In)	0.0
Yes	Refuge 2 Length (In)	36.0	No	Gutter 2 Ponding?	Yes
Yes	Refuge 2 Width (In)	96.0	No	Gutter 2 Lip Ht (In)	0.25
Yes	Refuge 2 Slope (%)	1.2	Yes	Gutter 2 Slope (%)	2.7
Yes	Refuge 2 X Slope (%)	1.2	Yes	Gutter 2 X Slope (%)	0.3
N/A	Painted X Walk2?	No	Yes	DWS 2 Provided?	Yes
N/A	X Walk 2 Direction	To W	Yes	DWS 2 Contrast?	Yes
N/A	X Walk 2 Width (In)	N/A	Yes	DWS 2 Length (In)	24.0

N/A	Road 2 Slope (%)	0.4	Yes	DWS 2 Full Width?	Yes
N/A	Road 2 X Slope (%)	2.5	Yes	DWS 2 Offset (In)	0.0
N/A	Refuge 3 Length (in)	N/A	N/A	Gutter 3 Ponding?	No
N/A	Refuge 3 Width (in)	N/A	N/A	Gutter 3 Lip Ht (in)	N/A
N/A	Refuge 3 Slope (%)	N/A	N/A	Gutter 3 Slope (%)	N/A
N/A	Refuge 3 XSlope (%)	N/A	N/A	Gutter 3 XSlope (%)	N/A
N/A	Painted X Walk3?	No	N/A	DWS 3 Provided?	N/A
N/A	X Walk 3 Direction	N/A	N/A	DWS 3 Contrast?	N/A
N/A	X Walk 3 Width (in)	N/A	N/A	DWS 3 Length (in)	N/A
N/A	Road 3 Slope (%)	N/A	N/A	DWS 3 Full Width?	N/A
N/A	Road 3 XSlope (%)	N/A	N/A	DWS 3 Offset (in)	N/A
Yes	Any Obstructions?	No	N/A	Storm Grate/Utility Hazard?	No
N/A	Obstruction Type		N/A	Storm Grate/Utility Type	
		N/A			N/A
N/A	Surface Condition	Good

Possible Solutions:

Grind Gutter Lip.
