Access Compliance Report

Public Rights-of-Way

(Island Curb Cuts)

Intersection ID: 10033070	Main Street: NORTH_COMMUNITY_HOUSE_RD	Cross Street: N/A	Location: N
ADA ID: F18A48D94236	Curb Cut Type: MedianRefuge2	Initial Pass/Fail: Fail	Overall Compliance: No
Codes/Mitigation Info/Possible Solution		Field Measurements/Component Compliance

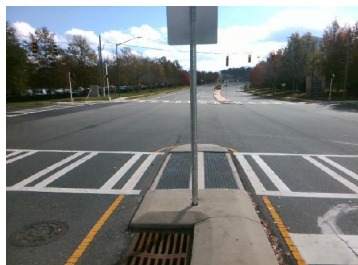
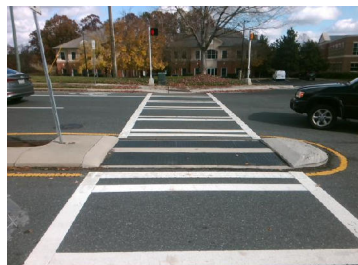
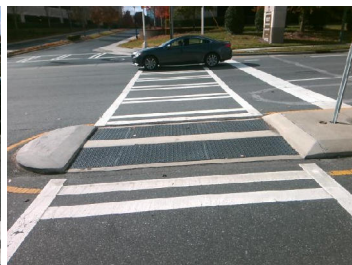
Compliance	Description	Data	Compliance	Description	Data
No	Refuge 1 Length (In)	33.5	N/A	Gutter 1 Ponding?	N/A
Yes	Refuge 1 Width (In)	118.5	N/A	Gutter 1 Lip Ht (In)	N/A
Yes	Refuge 1 Slope (%)	1.9	N/A	Gutter 1 Slope (%)	N/A
Yes	Refuge 1 X Slope (%)	2.3	N/A	Gutter 1 X Slope (%)	N/A
N/A	Painted X Walk1?	Yes	N/A	DWS 1 Provided?	N/A
N/A	X Walk 1 Direction	To SW	N/A	DWS 1 Contrast?	N/A
N/A	X Walk 1 Width (In)	110.0	N/A	DWS 1 Length (In)	N/A
N/A	Road 1 Slope (%)	2.1	N/A	DWS 1 Full Width?	N/A
N/A	Road 1 X Slope (%)	2.4	N/A	DWS 1 Offset (In)	N/A
No	Refuge 2 Length (In)	33.5	N/A	Gutter 2 Ponding?	N/A
Yes	Refuge 2 Width (In)	118.5	N/A	Gutter 2 Lip Ht (In)	N/A
Yes	Refuge 2 Slope (%)	4.3	N/A	Gutter 2 Slope (%)	N/A
Yes	Refuge 2 X Slope (%)	1.2	N/A	Gutter 2 X Slope (%)	N/A
N/A	Painted X Walk2?	Yes	N/A	DWS 2 Provided?	N/A
N/A	X Walk 2 Direction	To NE	N/A	DWS 2 Contrast?	N/A
N/A	X Walk 2 Width (In)	110.5	N/A	DWS 2 Length (In)	N/A

Remove & Replace Entire Refuge.
