Access Compliance Report

Public Rights-of-Way

(Island Curb Cuts)

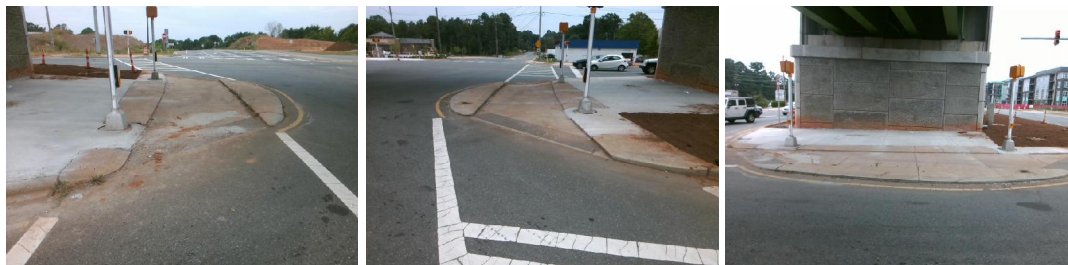
Intersection ID: 6957	Main Street: N_TRYON_ST	Cross Street: N_US_29_BY-PASS_HY	Location: S
ADA ID: F2008C9D04B7	Curb Cut Type: MedianRefuge2	Initial Pass/Fail: Fail	Overall Compliance: No
Severity Score: 1.25			
Codes/Mitigation Info/Possible Solution		Field Measurements/Component Compliance

Possible Solutions:

Remove & Replace Entire Refuge.
