Access Compliance Report

Public Rights-of-Way

(Island Curb Cuts)

Intersection ID: 3559	Main Street: PERIMETER_PY	Cross Street: W_W_T_HARRIS_BV	Location:	SW
ADA ID: F3B83AFA5E4C	Curb Cut Type: IslandRefuge3	Initial Pass/Fail: Fail	Overall Compliance: No	Severity Score: 47.5
Codes/Mitigation Info/Possible Solution		Field Measurements/Component Compliance

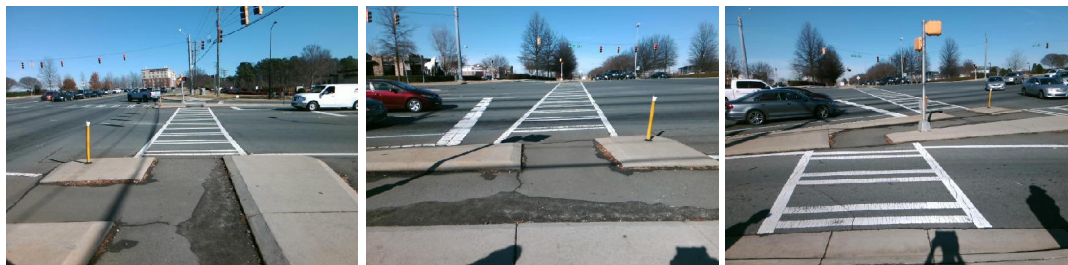
Compliance	Description	Data	Compliance	Description	Data
Yes	Refuge 1 Length (In)	72.0	N/A	Gutter 1 Ponding?	N/A
Yes	Refuge 1 Width (In)	72.0	N/A	Gutter 1 Lip Ht (In)	N/A
Yes	Refuge 1 Slope (%)	1.0	N/A	Gutter 1 Slope (%)	N/A
Yes	Refuge 1 X Slope (%)	3.4	N/A	Gutter 1 X Slope (%)	N/A
N/A	Painted X Walk1?	Yes	N/A	DWS 1 Provided?	N/A
N/A	X Walk 1 Direction	To E	N/A	DWS 1 Contrast?	N/A
N/A	X Walk 1 Width (In)	111.0	N/A	DWS 1 Length (In)	N/A
N/A	Road 1 Slope (%)	4.5	N/A	DWS 1 Full Width?	N/A
N/A	Road 1 X Slope (%)	0.1	N/A	DWS 1 Offset (In)	N/A
Yes	Refuge 2 Length (In)	69.0	N/A	Gutter 2 Ponding?	N/A
Yes	Refuge 2 Width (In)	72.0	N/A	Gutter 2 Lip Ht (In)	N/A
Yes	Refuge 2 Slope (%)	3.2	N/A	Gutter 2 Slope (%)	N/A
Yes	Refuge 2 X Slope (%)	1.2	N/A	Gutter 2 X Slope (%)	N/A
N/A	Painted X Walk2?	Yes	N/A	DWS 2 Provided?	N/A
N/A	X Walk 2 Direction	To N	N/A	DWS 2 Contrast?	N/A
N/A	X Walk 2 Width (In)	112.0	N/A	DWS 2 Length (In)	N/A

N/A	Road 2 Slope (%)	1.3	N/A	DWS 2 Full Width?	N/A
N/A	Road 2 X Slope (%)	3.5	N/A	DWS 2 Offset (In)	N/A
Yes	Refuge 3 Length (in)	42.0	N/A	Gutter 3 Ponding?	N/A
Yes	Refuge 3 Width (in)	72.0	N/A	Gutter 3 Lip Ht (in)	N/A
No	Refuge 3 Slope (%)	5.1	N/A	Gutter 3 Slope (%)	N/A
Yes	Refuge 3 XSlope (%)	0.5	N/A	Gutter 3 XSlope (%)	N/A
N/A	Painted X Walk3?	Yes	N/A	DWS 3 Provided?	N/A
N/A	X Walk 3 Direction	To SW	N/A	DWS 3 Contrast?	N/A
N/A	X Walk 3 Width (in)	109.0	N/A	DWS 3 Length (in)	N/A
N/A	Road 3 Slope (%)	1.2	N/A	DWS 3 Full Width?	N/A
N/A	Road 3 XSlope (%)	5.0	N/A	DWS 3 Offset (in)	N/A
Yes	Any Obstructions?	N/A	N/A	Storm Grate/Utility Hazard?	N/A
N/A	Obstruction Type		N/A	Storm Grate/Utility Type	
			N/A		N/A
N/A	Surface Condition	Good

Possible Solutions:

Remove & Replace Entire Refuge.
