Access Compliance Report

Public Rights-of-Way

(Island Curb Cuts)

Intersection ID: 10035806	Main Street: REMOUNT_RD	Cross Street: N/A	Location: N
ADA ID: F482504EDBDB	Curb Cut Type: MedianRefuge2	Initial Pass/Fail: Fail	Overall Compliance: No
Codes/Mitigation Info/Possible Solution		Field Measurements/Component Compliance

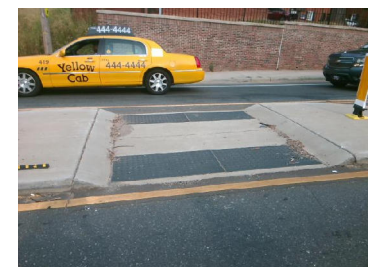
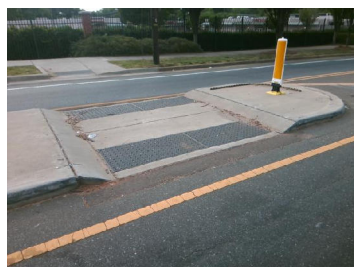
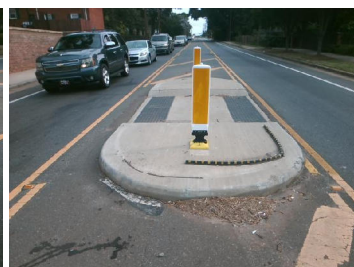
Compliance	Description	Data	Compliance	Description	Data
Yes	Refuge 1 Length (In)	53.0	N/A	Gutter 1 Ponding?	N/A
Yes	Refuge 1 Width (In)	96.0	N/A	Gutter 1 Lip Ht (In)	N/A
Yes	Refuge 1 Slope (%)	2.5	N/A	Gutter 1 Slope (%)	N/A
Yes	Refuge 1 X Slope (%)	3.1	N/A	Gutter 1 X Slope (%)	N/A
N/A	Painted X Walk1?	No	N/A	DWS 1 Provided?	N/A
N/A	X Walk 1 Direction	To E	N/A	DWS 1 Contrast?	N/A
N/A	X Walk 1 Width (In)	N/A	N/A	DWS 1 Length (In)	N/A
N/A	Road 1 Slope (%)	4.3	N/A	DWS 1 Full Width?	N/A
N/A	Road 1 X Slope (%)	6.0	N/A	DWS 1 Offset (In)	N/A
Yes	Refuge 2 Length (In)	55.0	N/A	Gutter 2 Ponding?	N/A
Yes	Refuge 2 Width (In)	96.0	N/A	Gutter 2 Lip Ht (In)	N/A
Yes	Refuge 2 Slope (%)	0.5	N/A	Gutter 2 Slope (%)	N/A
No	Refuge 2 X Slope (%)	5.7	N/A	Gutter 2 X Slope (%)	N/A
N/A	Painted X Walk2?	No	N/A	DWS 2 Provided?	N/A
N/A	X Walk 2 Direction	To W	N/A	DWS 2 Contrast?	N/A
N/A	X Walk 2 Width (In)	N/A	N/A	DWS 2 Length (In)	N/A

N/A	Road 2 Slope (%)	4.0	N/A	DWS 2 Full Width?	N/A
N/A	Road 2 X Slope (%)	1.3	N/A	DWS 2 Offset (In)	N/A
N/A	Refuge 3 Length (in)	N/A	N/A	Gutter 3 Ponding?	N/A
N/A	Refuge 3 Width (in)	N/A	N/A	Gutter 3 Lip Ht (in)	N/A
N/A	Refuge 3 Slope (%)	N/A	N/A	Gutter 3 Slope (%)	N/A
N/A	Refuge 3 XSlope (%)	N/A	N/A	Gutter 3 XSlope (%)	N/A
N/A	Painted X Walk3?	N/A	N/A	DWS 3 Provided?	N/A
N/A	X Walk 3 Direction	N/A	N/A	DWS 3 Contrast?	N/A
N/A	X Walk 3 Width (in)	N/A	N/A	DWS 3 Length (in)	N/A
N/A	Road 3 Slope (%)	N/A	N/A	DWS 3 Full Width?	N/A
N/A	Road 3 XSlope (%)	N/A	N/A	DWS 3 Offset (in)	N/A
Yes	Any Obstructions?	N/A	N/A	Storm Grate/Utility Hazard?	N/A
N/A	Obstruction Type		N/A	Storm Grate/Utility Type	
			N/A		N/A
N/A	Surface Condition	Good

Remove & Replace Entire Refuge.
