Access Compliance Report

Public Rights-of-Way

(Island Curb Cuts)

Intersection ID: 23977	Main Street: REA_RD	Cross Street: WINDYRUSH_RD	Location: E
ADA ID: F5919E304EE2	Curb Cut Type: MedianRefuge2	Initial Pass/Fail: Fail	Overall Compliance: No
Severity Score: 0			
Codes/Mitigation Info/Possible Solution		Field Measurements/Component Compliance

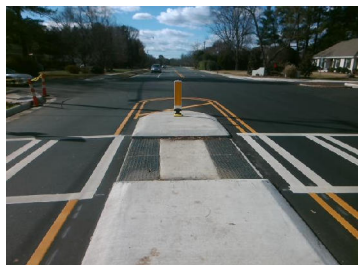
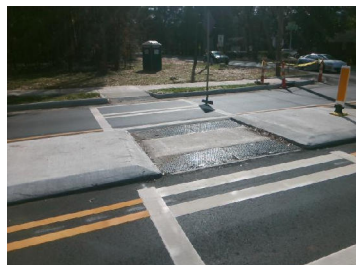
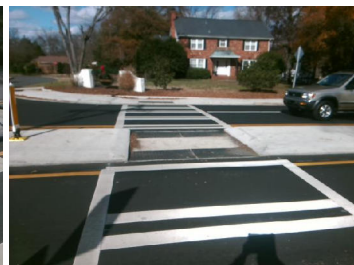
Compliance	Description	Data	Compliance	Description	Data
Yes	Refuge 1 Length (In)	44.0	N/A	Gutter 1 Ponding?	N/A
Yes	Refuge 1 Width (In)	96.0	N/A	Gutter 1 Lip Ht (In)	N/A
Yes	Refuge 1 Slope (%)	1.7	N/A	Gutter 1 Slope (%)	N/A
Yes	Refuge 1 X Slope (%)	4.6	N/A	Gutter 1 X Slope (%)	N/A
N/A	Painted X Walk1?	Yes	N/A	DWS 1 Provided?	N/A
N/A	X Walk 1 Direction	To NW	N/A	DWS 1 Contrast?	N/A
N/A	X Walk 1 Width (In)	111.0	N/A	DWS 1 Length (In)	N/A
N/A	Road 1 Slope (%)	3.8	N/A	DWS 1 Full Width?	N/A
N/A	Road 1 X Slope (%)	1.1	N/A	DWS 1 Offset (In)	N/A
Yes	Refuge 2 Length (In)	44.0	N/A	Gutter 2 Ponding?	N/A
Yes	Refuge 2 Width (In)	96.0	N/A	Gutter 2 Lip Ht (In)	N/A
Yes	Refuge 2 Slope (%)	1.2	N/A	Gutter 2 Slope (%)	N/A
Yes	Refuge 2 X Slope (%)	1.8	N/A	Gutter 2 X Slope (%)	N/A
N/A	Painted X Walk2?	Yes	N/A	DWS 2 Provided?	N/A
N/A	X Walk 2 Direction	To SE	N/A	DWS 2 Contrast?	N/A
N/A	X Walk 2 Width (In)	113.0	N/A	DWS 2 Length (In)	N/A

Possible Solutions:

Remove & Replace Entire Refuge.
