Access Compliance Report

Public Rights-of-Way

(Island Curb Cuts)

Intersection ID: 10040992	Main Street: WALTON_RD	Cross Street: N/A	Location: E
ADA ID: F6AF99A25506	Curb Cut Type: MedianRefuge2	Initial Pass/Fail: Fail	Overall Compliance: No
Codes/Mitigation Info/Possible Solution		Field Measurements/Component Compliance	
Severity Score: 25

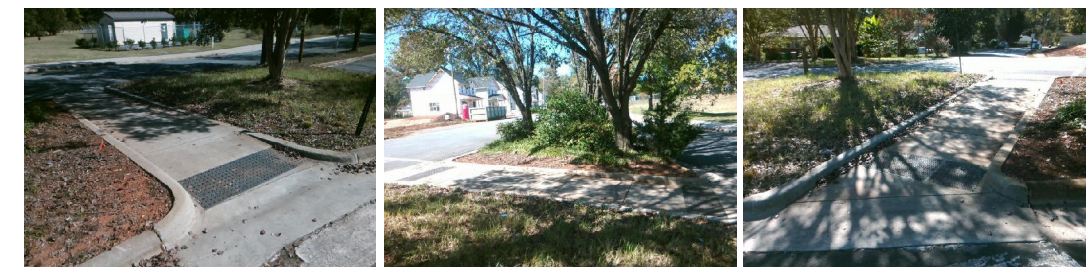
Compliance	Description	Data	Compliance	Description	Data
Yes	Refuge 1 Length (In)	149.0	N/A	Gutter 1 Ponding?	N/A
Yes	Refuge 1 Width (In)	71.0	N/A	Gutter 1 Lip Ht (In)	N/A
Yes	Refuge 1 Slope (%)	1.4	N/A	Gutter 1 Slope (%)	N/A
Yes	Refuge 1 X Slope (%)	3.3	N/A	Gutter 1 X Slope (%)	N/A
N/A	Painted X Walk1?	Yes	N/A	DWS 1 Provided?	N/A
N/A	X Walk 1 Direction	To W	N/A	DWS 1 Contrast?	N/A
N/A	X Walk 1 Width (In)	104.0	N/A	DWS 1 Length (In)	N/A
N/A	Road 1 Slope (%)	3.2	N/A	DWS 1 Full Width?	N/A
N/A	Road 1 X Slope (%)	5.9	N/A	DWS 1 Offset (In)	N/A
Yes	Refuge 2 Length (In)	149.0	N/A	Gutter 2 Ponding?	N/A
Yes	Refuge 2 Width (In)	71.0	N/A	Gutter 2 Lip Ht (In)	N/A
No	Refuge 2 Slope (%)	6.4	N/A	Gutter 2 Slope (%)	N/A
No	Refuge 2 X Slope (%)	5.1	N/A	Gutter 2 X Slope (%)	N/A
N/A	Painted X Walk2?	Yes	N/A	DWS 2 Provided?	N/A
N/A	X Walk 2 Direction	To NE	N/A	DWS 2 Contrast?	N/A
N/A	X Walk 2 Width (In)	98.0	N/A	DWS 2 Length (In)	N/A

N/A	Road 2 Slope (%)	6.1	N/A	DWS 2 Full Width?	N/A
N/A	Road 2 X Slope (%)	2.0	N/A	DWS 2 Offset (In)	N/A
N/A	Refuge 3 Length (in)	N/A	N/A	Gutter 3 Ponding?	N/A
N/A	Refuge 3 Width (in)	N/A	N/A	Gutter 3 Lip Ht (in)	N/A
N/A	Refuge 3 Slope (%)	N/A	N/A	Gutter 3 Slope (%)	N/A
N/A	Refuge 3 XSlope (%)	N/A	N/A	Gutter 3 XSlope (%)	N/A
N/A	Painted X Walk3?	N/A	N/A	DWS 3 Provided?	N/A
N/A	X Walk 3 Direction	N/A	N/A	DWS 3 Contrast?	N/A
N/A	X Walk 3 Width (in)	N/A	N/A	DWS 3 Length (in)	N/A
N/A	Road 3 Slope (%)	N/A	N/A	DWS 3 Full Width?	N/A
N/A	Road 3 XSlope (%)	N/A	N/A	DWS 3 Offset (in)	N/A
Yes	Any Obstructions?	N/A	N/A	Storm Grate/Utility Hazard?	N/A
N/A	Obstruction Type		N/A	Storm Grate/Utility Type	
		N/A			N/A
N/A	Surface Condition	Good

Remove & Replace Entire Refuge.
