# Access Compliance Report

## Public Rights-of-Way

### (Island Curb Cuts)

Intersection ID: 18818	Main Street: BEAM_RD	Cross Street: SHOPTON_RD	Location: W
ADA ID: F7C944A15934	Curb Cut Type: MedianRefuge2	Initial Pass/Fail: Fail	Overall Compliance: No
Severity Score: 1.25			
Codes/Mitigation Info/Possible Solution		Field Measurements/Component Compliance

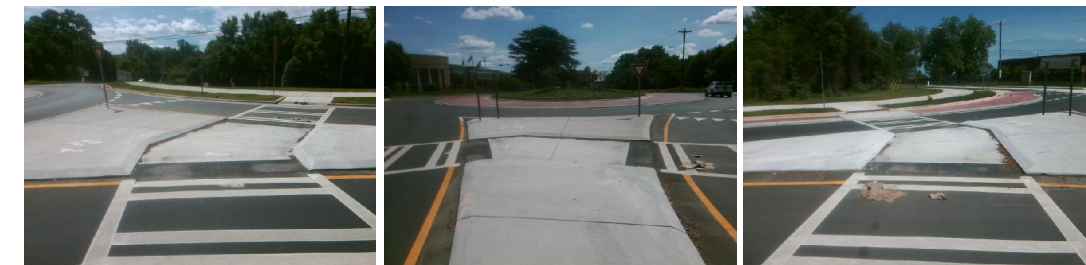
Compliance	Description	Data	Compliance	Description	Data
Yes	Refuge 1 Length (In)	105	N/A	Gutter 1 Ponding?	N/A
Yes	Refuge 1 Width (In)	119	N/A	Gutter 1 Lip Ht (In)	N/A
Yes	Refuge 1 Slope (%)	0.3	N/A	Gutter 1 Slope (%)	N/A
Yes	Refuge 1 X Slope (%)	3.7	N/A	Gutter 1 X Slope (%)	N/A
N/A	Painted X Walk1?	Yes	N/A	DWS 1 Provided?	N/A
N/A	X Walk 1 Direction	To N	N/A	DWS 1 Contrast?	N/A
N/A	X Walk 1 Width (In)	112	N/A	DWS 1 Length (In)	N/A
N/A	Road 1 Slope (%)	1.9	N/A	DWS 1 Full Width?	N/A
N/A	Road 1 X Slope (%)	1.2	N/A	DWS 1 Offset (In)	N/A
Yes	Refuge 2 Length (In)	105	N/A	Gutter 2 Ponding?	N/A
Yes	Refuge 2 Width (In)	119	N/A	Gutter 2 Lip Ht (In)	N/A
Yes	Refuge 2 Slope (%)	3.9	N/A	Gutter 2 Slope (%)	N/A
Yes	Refuge 2 X Slope (%)	0.8	N/A	Gutter 2 X Slope (%)	N/A
N/A	Painted X Walk2?	Yes	N/A	DWS 2 Provided?	N/A
N/A	X Walk 2 Direction	To S	N/A	DWS 2 Contrast?	N/A
N/A	X Walk 2 Width (In)	112	N/A	DWS 2 Length (In)	N/A

N/A	Road 2 Slope (%)	0.3	N/A	DWS 2 Full Width?	N/A
N/A	Road 2 X Slope (%)	3.6	N/A	DWS 2 Offset (In)	N/A
N/A	Refuge 3 Length (in)	N/A	N/A	Gutter 3 Ponding?	N/A
N/A	Refuge 3 Width (in)	N/A	N/A	Gutter 3 Lip Ht (in)	N/A
N/A	Refuge 3 Slope (%)	N/A	N/A	Gutter 3 Slope (%)	N/A
N/A	Refuge 3 XSlope (%)	N/A	N/A	Gutter 3 XSlope (%)	N/A
N/A	Painted X Walk3?	N/A	N/A	DWS 3 Provided?	N/A
N/A	X Walk 3 Direction	N/A	N/A	DWS 3 Contrast?	N/A
N/A	X Walk 3 Width (in)	N/A	N/A	DWS 3 Length (in)	N/A
N/A	Road 3 Slope (%)	N/A	N/A	DWS 3 Full Width?	N/A
N/A	Road 3 XSlope (%)	N/A	N/A	DWS 3 Offset (in)	N/A
Yes	Any Obstructions?	N/A	N/A	Storm Grate/Utility Hazard?	N/A
N/A	Obstruction Type		N/A	Storm Grate/Utility Type	
		N/A			N/A
N/A	Surface Condition	Good

**Remove & Replace Entire Refuge.**
