Access Compliance Report

Public Rights-of-Way

(Island Curb Cuts)

Intersection ID: 15800	Main Street: PROVIDENCE_RD	Cross Street: QUEENS_RD	Location:	SW
ADA ID: F9455288E701	Curb Cut Type: IslandRefuge3	Initial Pass/Fail: Fail	Overall Compliance: No	Severity Score: 47.5
Codes/Mitigation Info/Possible Solution		Field Measurements/Component Compliance

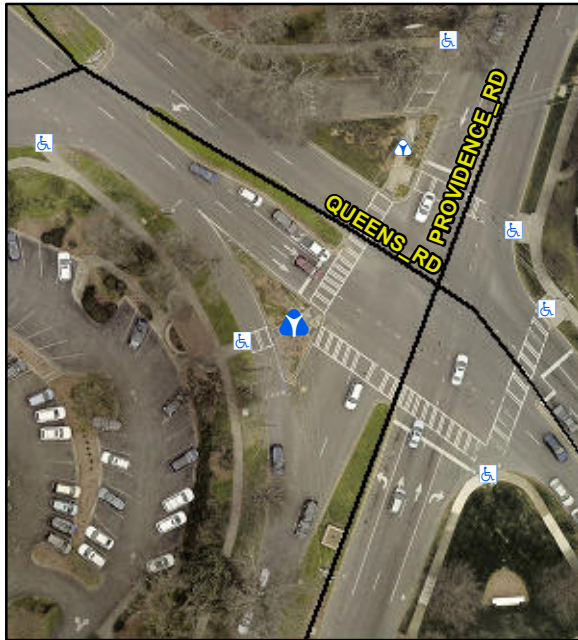
Compliance	Description	Data	Compliance	Description	Data
Yes	Refuge 1 Length (In)	146.0	N/A	Gutter 1 Ponding?	N/A
No	Refuge 1 Width (In)	56.0	N/A	Gutter 1 Lip Ht (In)	N/A
No	Refuge 1 Slope (%)	5.1	N/A	Gutter 1 Slope (%)	N/A
Yes	Refuge 1 X Slope (%)	2.8	N/A	Gutter 1 X Slope (%)	N/A
N/A	Painted X Walk1?	Yes	N/A	DWS 1 Provided?	N/A
N/A	X Walk 1 Direction	To SW	N/A	DWS 1 Contrast?	N/A
N/A	X Walk 1 Width (In)	110.0	N/A	DWS 1 Length (In)	N/A
N/A	Road 1 Slope (%)	2.3	N/A	DWS 1 Full Width?	N/A
N/A	Road 1 X Slope (%)	5.2	N/A	DWS 1 Offset (In)	N/A
Yes	Refuge 2 Length (In)	93.0	N/A	Gutter 2 Ponding?	N/A
No	Refuge 2 Width (In)	55.0	N/A	Gutter 2 Lip Ht (In)	N/A
Yes	Refuge 2 Slope (%)	1.3	N/A	Gutter 2 Slope (%)	N/A
Yes	Refuge 2 X Slope (%)	1.5	N/A	Gutter 2 X Slope (%)	N/A
N/A	Painted X Walk2?	Yes	N/A	DWS 2 Provided?	N/A
N/A	X Walk 2 Direction	To NE	N/A	DWS 2 Contrast?	N/A
N/A	X Walk 2 Width (In)	112.0	N/A	DWS 2 Length (In)	N/A

N/A	Road 2 Slope (%)	2.1	N/A	DWS 2 Full Width?	N/A
N/A	Road 2 X Slope (%)	0.8	N/A	DWS 2 Offset (In)	N/A
Yes	Refuge 3 Length (in)	77.0	N/A	Gutter 3 Ponding?	N/A
No	Refuge 3 Width (in)	57.0	N/A	Gutter 3 Lip Ht (in)	N/A
Yes	Refuge 3 Slope (%)	2.1	N/A	Gutter 3 Slope (%)	N/A
Yes	Refuge 3 XSlope (%)	2.6	N/A	Gutter 3 XSlope (%)	N/A
N/A	Painted X Walk3?	Yes	N/A	DWS 3 Provided?	N/A
N/A	X Walk 3 Direction	To SE	N/A	DWS 3 Contrast?	N/A
N/A	X Walk 3 Width (in)	114.0	N/A	DWS 3 Length (in)	N/A
N/A	Road 3 Slope (%)	1.0	N/A	DWS 3 Full Width?	N/A
N/A	Road 3 XSlope (%)	0.8	N/A	DWS 3 Offset (in)	N/A
Yes	Any Obstructions?	N/A	N/A	Storm Grate/Utility Hazard?	N/A
N/A	Obstruction Type		N/A	Storm Grate/Utility Type	
			N/A		N/A
N/A	Surface Condition	Good

Remove & Replace Entire Refuge.
