# Access Compliance Report

## Public Rights-of-Way

### (Island Curb Cuts)

Intersection ID: 19817	Main Street: MONROE_RD	Cross Street: TIMBER_SPRINGS_DR	Location: SW
ADA ID: FA9761A9E819	Curb Cut Type: IslandRefuge3	Initial Pass/Fail: Pass	Overall Compliance: No
Codes/Mitigation Info/Possible Solution		Field Measurements/Component Compliance	
Severity Score: 10

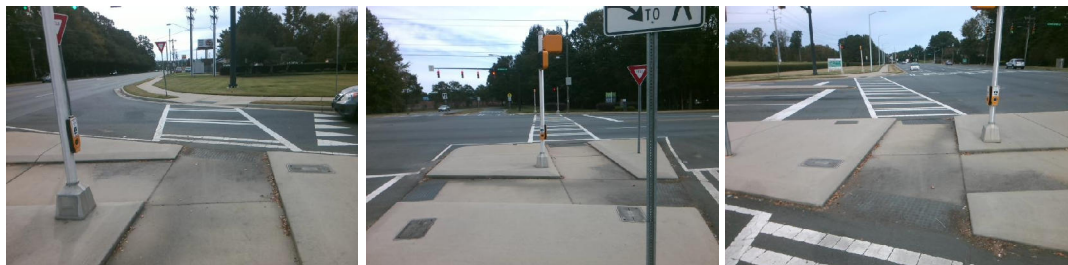
Compliance	Description	Data	Compliance	Description	Data
Yes	Refuge 1 Length (In)	36.0	Yes	Gutter 1 Ponding?	No
Yes	Refuge 1 Width (In)	72.0	Yes	Gutter 1 Lip Ht (In)	0.0
Yes	Refuge 1 Slope (%)	0.6	Yes	Gutter 1 Slope (%)	1.4
Yes	Refuge 1 X Slope (%)	0.9	Yes	Gutter 1 X Slope (%)	0.7
N/A	Painted X Walk1?	Yes	Yes	DWS 1 Provided?	Yes
N/A	X Walk 1 Direction	To SE	Yes	DWS 1 Contrast?	Yes
N/A	X Walk 1 Width (In)	111.0	Yes	DWS 1 Length (In)	24.0
N/A	Road 1 Slope (%)	1.0	No	DWS 1 Full Width?	No
N/A	Road 1 X Slope (%)	0.6	Yes	DWS 1 Offset (In)	0.0
Yes	Refuge 2 Length (In)	195.0	Yes	Gutter 2 Ponding?	No
Yes	Refuge 2 Width (In)	72.0	Yes	Gutter 2 Lip Ht (In)	0.0
Yes	Refuge 2 Slope (%)	1.2	Yes	Gutter 2 Slope (%)	4.8
Yes	Refuge 2 X Slope (%)	1.0	Yes	Gutter 2 X Slope (%)	0.2
N/A	Painted X Walk2?	Yes	Yes	DWS 2 Provided?	Yes
N/A	X Walk 2 Direction	To NE	Yes	DWS 2 Contrast?	Yes
N/A	X Walk 2 Width (In)	114.0	Yes	DWS 2 Length (In)	24.0

N/A	Road 2 Slope (%)	1.1	No	DWS 2 Full Width?	No
N/A	Road 2 X Slope (%)	2.9	Yes	DWS 2 Offset (In)	0.0
Yes	Refuge 3 Length (in)	133.0	Yes	Gutter 3 Ponding?	No
Yes	Refuge 3 Width (in)	70.0	Yes	Gutter 3 Lip Ht (in)	0.0
Yes	Refuge 3 Slope (%)	0.5	Yes	Gutter 3 Slope (%)	1.0
Yes	Refuge 3 XSlope (%)	0.9	Yes	Gutter 3 XSlope (%)	0.0
N/A	Painted X Walk3?	Yes	Yes	DWS 3 Provided?	Yes
N/A	X Walk 3 Direction	To NW	Yes	DWS 3 Contrast?	Yes
N/A	X Walk 3 Width (in)	112.0	Yes	DWS 3 Length (in)	24.0
N/A	Road 3 Slope (%)	0.3	No	DWS 3 Full Width?	No
N/A	Road 3 XSlope (%)	1.6	Yes	DWS 3 Offset (in)	0.0
Yes	Any Obstructions?	N/A	N/A	Storm Grate/Utility Hazard?	No
N/A	Obstruction Type	N/A	N/A	Storm Grate/Utility Type	N/A
N/A	Surface Condition	Good

**Remove & Replace Detectable Warning System.**
