# Access Compliance Report

## Public Rights-of-Way

### (Island Curb Cuts)

Intersection ID: 12158	Main Street: W_MOREHEAD_ST	Cross Street: SUTTLE_AVE	Location: S
ADA ID: FC7D4DDCA366	Curb Cut Type: MedianRefuge2	Initial Pass/Fail: Fail	Overall Compliance: No
Codes/Mitigation Info/Possible Solution		Field Measurements/Component Compliance

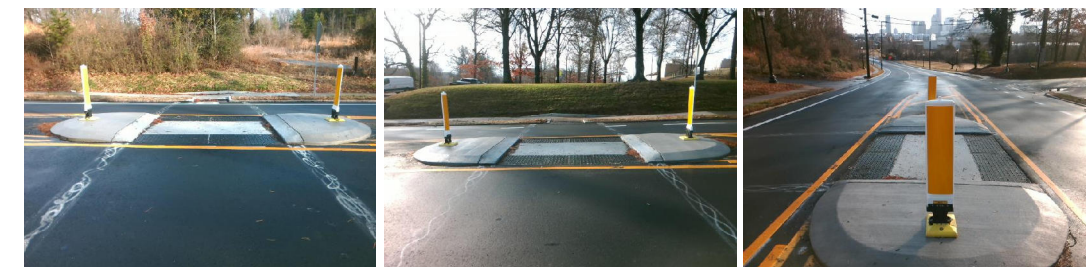
Compliance	Description	Data	Compliance	Description	Data
Yes	Refuge 1 Length (In)	49.0	N/A	Gutter 1 Ponding?	N/A
Yes	Refuge 1 Width (In)	98.0	N/A	Gutter 1 Lip Ht (In)	N/A
Yes	Refuge 1 Slope (%)	1.9	N/A	Gutter 1 Slope (%)	N/A
No	Refuge 1 X Slope (%)	6.9	N/A	Gutter 1 X Slope (%)	N/A
N/A	Painted X Walk1?	No	N/A	DWS 1 Provided?	N/A
N/A	X Walk 1 Direction	To S	N/A	DWS 1 Contrast?	N/A
N/A	X Walk 1 Width (In)	N/A	N/A	DWS 1 Length (In)	N/A
N/A	Road 1 Slope (%)	8.2	N/A	DWS 1 Full Width?	N/A
N/A	Road 1 X Slope (%)	4.2	N/A	DWS 1 Offset (In)	N/A
Yes	Refuge 2 Length (In)	49.0	N/A	Gutter 2 Ponding?	N/A
Yes	Refuge 2 Width (In)	98.0	N/A	Gutter 2 Lip Ht (In)	N/A
Yes	Refuge 2 Slope (%)	2.2	N/A	Gutter 2 Slope (%)	N/A
No	Refuge 2 X Slope (%)	7.5	N/A	Gutter 2 X Slope (%)	N/A
N/A	Painted X Walk2?	No	N/A	DWS 2 Provided?	N/A
N/A	X Walk 2 Direction	To N	N/A	DWS 2 Contrast?	N/A
N/A	X Walk 2 Width (In)	N/A	N/A	DWS 2 Length (In)	N/A

N/A	Road 2 Slope (%)	7.2	N/A	DWS 2 Full Width?	N/A
N/A	Road 2 X Slope (%)	4.6	N/A	DWS 2 Offset (In)	N/A
N/A	Refuge 3 Length (in)	N/A	N/A	Gutter 3 Ponding?	N/A
N/A	Refuge 3 Width (in)	N/A	N/A	Gutter 3 Lip Ht (in)	N/A
N/A	Refuge 3 Slope (%)	N/A	N/A	Gutter 3 Slope (%)	N/A
N/A	Refuge 3 XSlope (%)	N/A	N/A	Gutter 3 XSlope (%)	N/A
N/A	Painted X Walk3?	N/A	N/A	DWS 3 Provided?	N/A
N/A	X Walk 3 Direction	N/A	N/A	DWS 3 Contrast?	N/A
N/A	X Walk 3 Width (in)	N/A	N/A	DWS 3 Length (in)	N/A
N/A	Road 3 Slope (%)	N/A	N/A	DWS 3 Full Width?	N/A
N/A	Road 3 XSlope (%)	N/A	N/A	DWS 3 Offset (in)	N/A
Yes	Any Obstructions?	N/A	N/A	Storm Grate/Utility Hazard?	N/A
N/A	Obstruction Type		N/A	Storm Grate/Utility Type	
		N/A			N/A
N/A	Surface Condition	Good

**Remove & Replace Entire Refuge.**
