Access Compliance Report

Public Rights-of-Way

(Island Curb Cuts)

| Intersection ID: 44850 | Main Street: STEELE_CREEK_RD | Cross Street: SHOPTON_RD_WEST | Location: W |

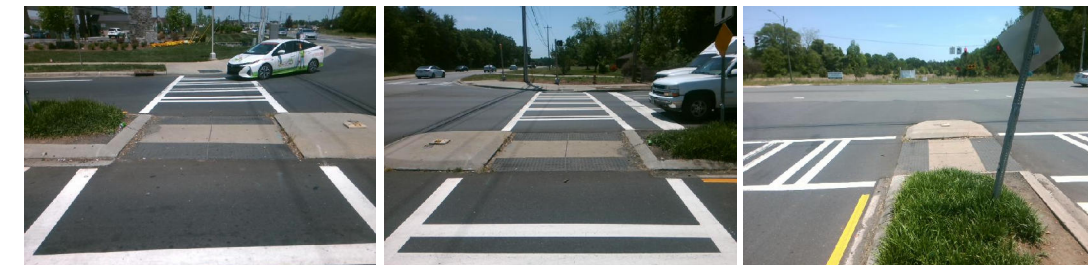
| ADA ID: FC7E6D5C3106 | Curb Cut Type: MedianRefuge2 | Initial Pass/Fail: Fail | Overall Compliance: No |
| Severity Score: 1.25 | | | |

Possible Solutions:

Remove & Replace Entire Refuge.
