Access Compliance Report

Public Rights-of-Way

(Island Curb Cuts)

Intersection ID: 47611	Main Street: WYALONG_DR	Cross Street: MINTWORTH_AV	Location: SE
ADA ID: FD3D619AEA1C	Curb Cut Type: MedianRefuge2	Initial Pass/Fail: Fail	Overall Compliance: No
Codes/Mitigation Info/Possible Solution		Field Measurements/Component Compliance	
Severity Score: 8.75

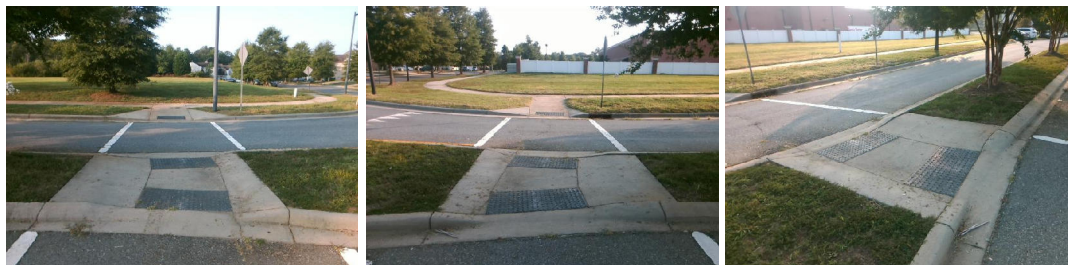
Compliance	Description	Data	Compliance	Description	Data
Yes	Refuge 1 Length (In)	44.5	N/A	Gutter 1 Ponding?	N/A
No	Refuge 1 Width (In)	48.0	N/A	Gutter 1 Lip Ht (In)	N/A
Yes	Refuge 1 Slope (%)	1.9	N/A	Gutter 1 Slope (%)	N/A
Yes	Refuge 1 X Slope (%)	5.0	N/A	Gutter 1 X Slope (%)	N/A
N/A	Painted X Walk1?	Yes	N/A	DWS 1 Provided?	N/A
N/A	X Walk 1 Direction	To SW	N/A	DWS 1 Contrast?	N/A
N/A	X Walk 1 Width (In)	119.0	N/A	DWS 1 Length (In)	N/A
N/A	Road 1 Slope (%)	2.3	N/A	DWS 1 Full Width?	N/A
N/A	Road 1 X Slope (%)	1.3	N/A	DWS 1 Offset (In)	N/A
Yes	Refuge 2 Length (In)	44.5	N/A	Gutter 2 Ponding?	N/A
No	Refuge 2 Width (In)	48.0	N/A	Gutter 2 Lip Ht (In)	N/A
Yes	Refuge 2 Slope (%)	0.6	N/A	Gutter 2 Slope (%)	N/A
Yes	Refuge 2 X Slope (%)	3.6	N/A	Gutter 2 X Slope (%)	N/A
N/A	Painted X Walk2?	Yes	N/A	DWS 2 Provided?	N/A
N/A	X Walk 2 Direction	To NE	N/A	DWS 2 Contrast?	N/A
N/A	X Walk 2 Width (In)	120.0	N/A	DWS 2 Length (In)	N/A

N/A	Road 2 Slope (%)	1.2	N/A	DWS 2 Full Width?	N/A
N/A	Road 2 X Slope (%)	2.0	N/A	DWS 2 Offset (In)	N/A
N/A	Refuge 3 Length (in)	N/A	N/A	Gutter 3 Ponding?	N/A
N/A	Refuge 3 Width (in)	N/A	N/A	Gutter 3 Lip Ht (in)	N/A
N/A	Refuge 3 Slope (%)	N/A	N/A	Gutter 3 Slope (%)	N/A
N/A	Refuge 3 XSlope (%)	N/A	N/A	Gutter 3 XSlope (%)	N/A
N/A	Painted X Walk3?	N/A	N/A	DWS 3 Provided?	N/A
N/A	X Walk 3 Direction	N/A	N/A	DWS 3 Contrast?	N/A
N/A	X Walk 3 Width (in)	N/A	N/A	DWS 3 Length (in)	N/A
N/A	Road 3 Slope (%)	N/A	N/A	DWS 3 Full Width?	N/A
N/A	Road 3 XSlope (%)	N/A	N/A	DWS 3 Offset (in)	N/A
Yes	Any Obstructions?	N/A	N/A	Storm Grate/Utility Hazard?	N/A
N/A	Obstruction Type		N/A	Storm Grate/Utility Type	
		N/A			N/A
N/A	Surface Condition	Good

Possible Solutions:

Remove & Replace Entire Refuge.
