Access Compliance Report

Public Rights-of-Way

(Island Curb Cuts)

Intersection ID: 54269	Main Street: JOHNSTON_OEHLER_RD	Cross Street: OEHLER_BRIDGE_DR	Location: N
ADA ID: FEB9F61EBC89	Curb Cut Type: MedianRefuge2	Initial Pass/Fail: Fail	Overall Compliance: No
Severity Score: 1.25			
Codes/Mitigation Info/Possible Solution		Field Measurements/Component Compliance

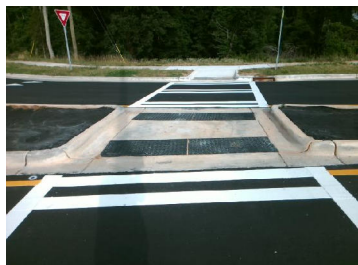
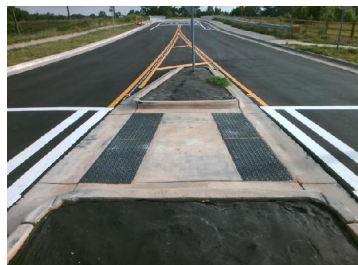
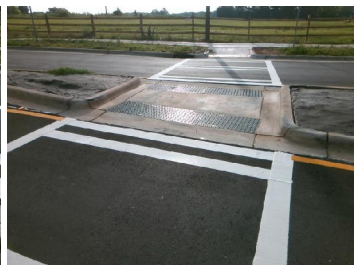
Compliance	Description	Data	Compliance	Description	Data
Yes	Refuge 1 Length (In)	42.0	N/A	Gutter 1 Ponding?	N/A
Yes	Refuge 1 Width (In)	116.0	N/A	Gutter 1 Lip Ht (In)	N/A
Yes	Refuge 1 Slope (%)	2.7	N/A	Gutter 1 Slope (%)	N/A
Yes	Refuge 1 X Slope (%)	3.7	N/A	Gutter 1 X Slope (%)	N/A
N/A	Painted X Walk1?	Yes	N/A	DWS 1 Provided?	N/A
N/A	X Walk 1 Direction	To E	N/A	DWS 1 Contrast?	N/A
N/A	X Walk 1 Width (In)	112.0	N/A	DWS 1 Length (In)	N/A
N/A	Road 1 Slope (%)	2.8	N/A	DWS 1 Full Width?	N/A
N/A	Road 1 X Slope (%)	2.7	N/A	DWS 1 Offset (In)	N/A
Yes	Refuge 2 Length (In)	42.0	N/A	Gutter 2 Ponding?	N/A
Yes	Refuge 2 Width (In)	116.0	N/A	Gutter 2 Lip Ht (In)	N/A
Yes	Refuge 2 Slope (%)	0.5	N/A	Gutter 2 Slope (%)	N/A
Yes	Refuge 2 X Slope (%)	3.4	N/A	Gutter 2 X Slope (%)	N/A
N/A	Painted X Walk2?	Yes	N/A	DWS 2 Provided?	N/A
N/A	X Walk 2 Direction	To W	N/A	DWS 2 Contrast?	N/A
N/A	X Walk 2 Width (In)	112.0	N/A	DWS 2 Length (In)	N/A

N/A	Road 2 Slope (%)	3.6	N/A	DWS 2 Full Width?	N/A
N/A	Road 2 X Slope (%)	1.8	N/A	DWS 2 Offset (In)	N/A
N/A	Refuge 3 Length (in)	N/A	N/A	Gutter 3 Ponding?	N/A
N/A	Refuge 3 Width (in)	N/A	N/A	Gutter 3 Lip Ht (in)	N/A
N/A	Refuge 3 Slope (%)	N/A	N/A	Gutter 3 Slope (%)	N/A
N/A	Refuge 3 XSlope (%)	N/A	N/A	Gutter 3 XSlope (%)	N/A
N/A	Painted X Walk3?	N/A	N/A	DWS 3 Provided?	N/A
N/A	X Walk 3 Direction	N/A	N/A	DWS 3 Contrast?	N/A
N/A	X Walk 3 Width (in)	N/A	N/A	DWS 3 Length (in)	N/A
N/A	Road 3 Slope (%)	N/A	N/A	DWS 3 Full Width?	N/A
N/A	Road 3 XSlope (%)	N/A	N/A	DWS 3 Offset (in)	N/A
Yes	Any Obstructions?	N/A	N/A	Storm Grate/Utility Hazard?	N/A
N/A	Obstruction Type		N/A	Storm Grate/Utility Type	
		N/A			N/A
N/A	Surface Condition	Good

Remove & Replace Entire Refuge.
