Access Compliance Report

# Public Rights-of-Way
(Curb Ramps)

Intersection ID: 16634	Main Street: OLD_PINEVILLE_RD	Cross Street: YANCEY_RD	Location:	NW
ADA ID: 76CDC0434D84	Ramp Type: PerpDiag	Initial Pass/Fail: Fail	Overall Compliance: No	Severity Score: 8.75

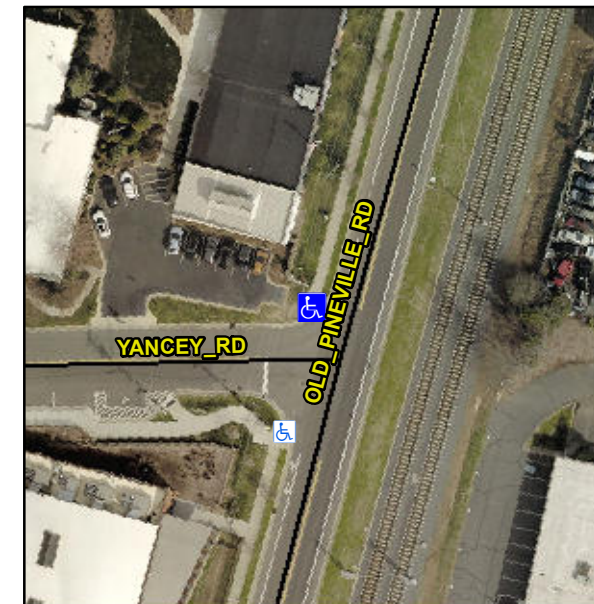
Not Found, R304.5.1

Compliance	Description	Data	Compliance	Description	Data
N/A	Ramp Length (in)	47.0	Yes	Ramp Slope (%)	8.0
No	Ramp Width (in)	46.0	Yes	Ramp XSlope (%)	0.9
N/A	Flare Type LT	N/A	N/A	Flare Type RT	N/A
N/A	Flare Slope LT (%)	N/A	N/A	Flare Slope RT (%)	N/A
N/A	Flare Traversable LT?	N/A	N/A	Flare Traversable RT?	N/A
N/A	Landing Length (in)	N/A	N/A	DWS Provided?	N/A
N/A	Landing Width (in)	N/A	N/A	DWS Contrast?	N/A
N/A	Landing Slope (%)	N/A	N/A	DWS Length (in)	N/A
N/A	Landing X Slope (%)	N/A	N/A	DWS Full Width?	N/A
N/A	Landing Curb? (Y/N)	N/A	N/A	DWS Offset (in)	N/A
N/A	Shared Landing?	N/A			
N/A	Gutter Ponding?	N/A	N/A	Gutter Slope (%)	N/A
N/A	Gutter Lip Ht (in)	N/A	N/A	Gutter X Slope (%)	N/A
N/A	Painted X Walk1?	No	N/A	Painted X Walk2?	No
	X Walk 1 Direction	To SW		X Walk 2 Direction	To E
N/A	X Walk 1 Width (in)	N/A	N/A	X Walk 2 Width (in)	N/A
	X Walk 1 Slope (%)	1.5		X Walk 2 Slope (%)	4.0
	X Walk 1 X Slope (%)	1.5		X Walk 2 X Slope (%)	0.6

Remove & Replace Curb Ramp With Two New Directional Ramps or Equivalent.
