# Access Compliance Report

## Public Rights-of-Way

### (Curb Ramps)

| Intersection ID: 10025497 | Main Street: E MARTIN LUTHER KING JR BV | Cross Street: N/A | Location: NW |

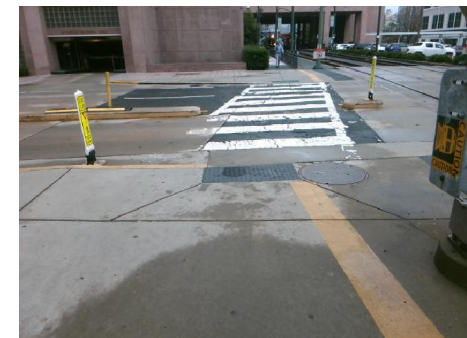
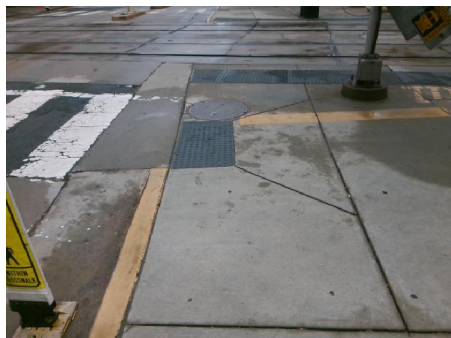
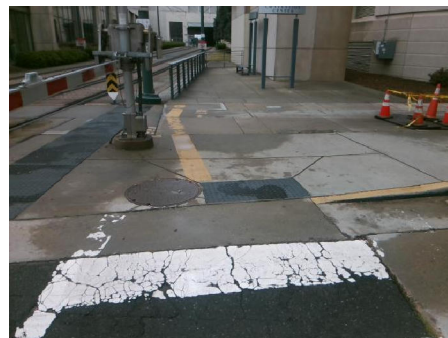
| ADA ID: 819A3F7A937F | Ramp Type: BlendTrans1 | Initial Pass/Fail: Pass | Overall Compliance: Yes |
